ADCI Advisory Notice

ADCI Informational Update 2014 - 37

Injuries due to Failure of Diver's Emergency Gas Cylinder

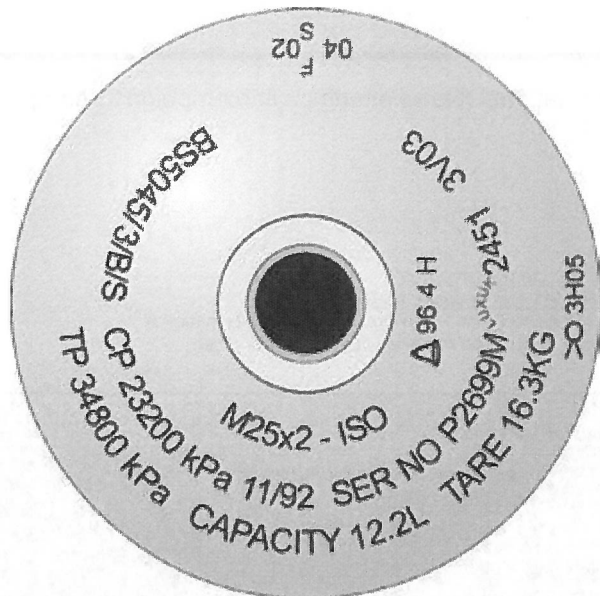
Figure 1: Permanent markings on top of air cylinder with thread specs: M25x2 - ISO.

The HP gas cylinder inner thread was an M25x2 parallel thread, and the outer thread on the pillar valve was a 1/2"x14 BSP parallel thread (Whitworth). How the incompatible valve and HP gas cylinders came to be used together is still being investigated.

- Check HP gas cylinder threads and pillar valve threads for compatibility.
- Mark the cylinder thread size for all HP cylinders; mark the thread size for all pillar valves, applying a unique identification that will be permanently visible and traceable.
- Have working procedures and instructions in place that include the verification of the compatibility of both the pillar valves and HP gas cylinders.
- Include compliance with ADCI Consensus Standards, which require annual internal and external visual inspections of HP gas cylinders.*
- Include the HP gas cylinder and pillar valve identification numbers in the annual inspection.*
- Observe the above recommended actions when using this type of cylinder, outside of diving, due to the potential for the same type of failure.

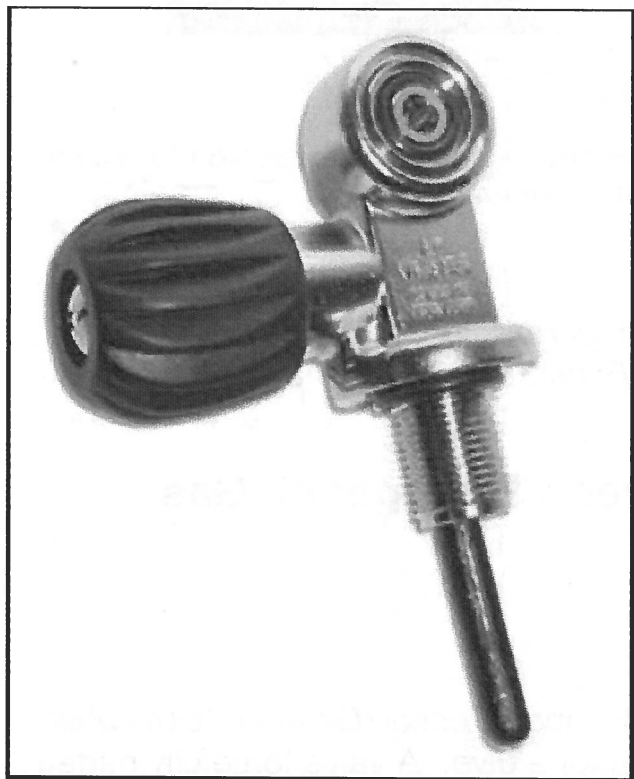
Figure 2: Example of pillar valve with 3/4" BSP parallel thread and no markings or thread specs.

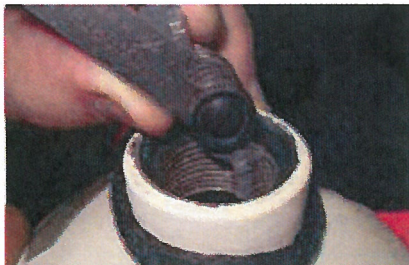
Figure 3: Inspection of the inner thread type at an HP gas cylinder.

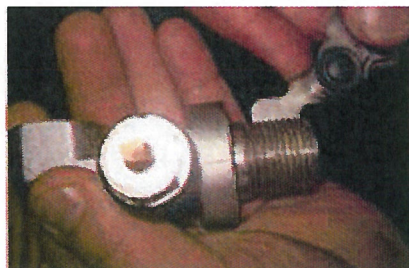
Figure 4: Inspection of the outer thread type at a pillar valve.
