# TECHNICAL MEMORANDUM

**Date:** June 14, 2023  
**To:** Alex Levell, Lummi Nation Natural Resources Department  
**From:** Brian Scott; Ian Mostrenko, PE; Herrera Environmental Consultants, Inc.  
**Subject:** South Fork Nooksack River Skookum-Edfro Reach Phase 3 Existing Conditions and Habitat Restoration Opportunities

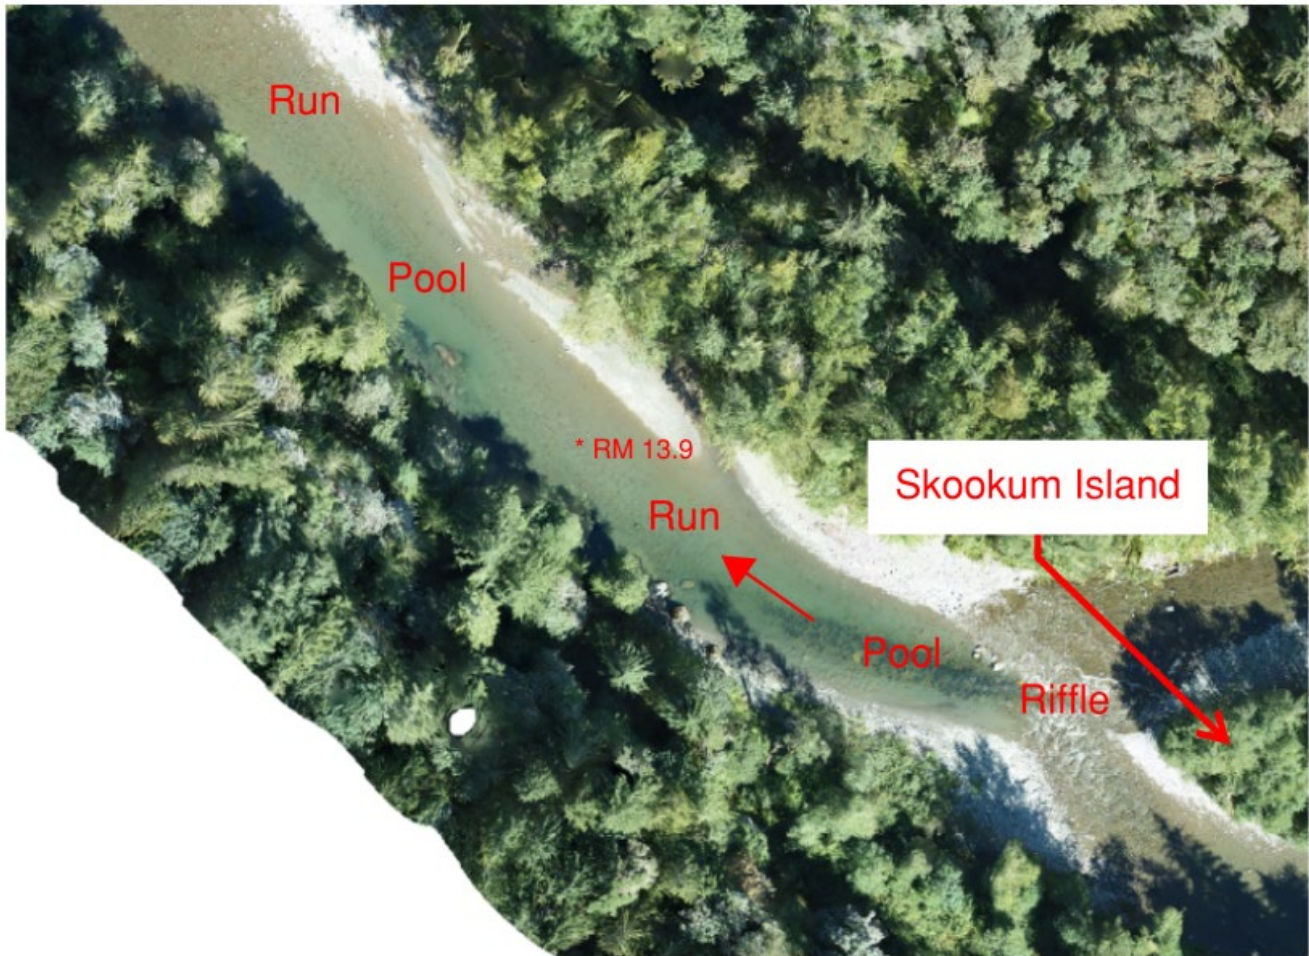
Figure 2. Phase 3 Sub-Reach 1 (RM 13.95–RM 13.85).

Sub-reach 1 begins where the north and south channels that flow around Skookum Island converge to form a deep primary convergence pool (Figure 2). This sub-reach includes said pool and a large and deep secondary pool downstream. Deep and slowly flowing runs have developed downstream of each pool. No bank armoring (riprap) is present; however, the left bank is mostly bedrock and lateral migration rates into the left bank is extremely low. Both banks are vegetated with native trees and shrubs. Both pools are primary holding areas for upstream migrating adult salmon; therefore, restoration measures should not cause a decrease in size or depth of them but rather strive to provide woody cover in them if possible and increase channel planform and bed complexity to increase pool frequency.

- Multiple small (5 to 10 feet wide/25 to 100 square feet (sf) in area) and medium sized (15 to 30 feet wide/225 to 900 sf) ELJs can be located near and between the pools and along the graveled banks to provide cover and significantly increase bed form and habitat complexity.
- One or two medium ELJs can be located along the left bank on the gravel bar at the downstream end of the sub-reach where the downstream most run begins to transition to the downstream riffle near RM 13.80, as shown in Figure 3 for Sub-reach 2.

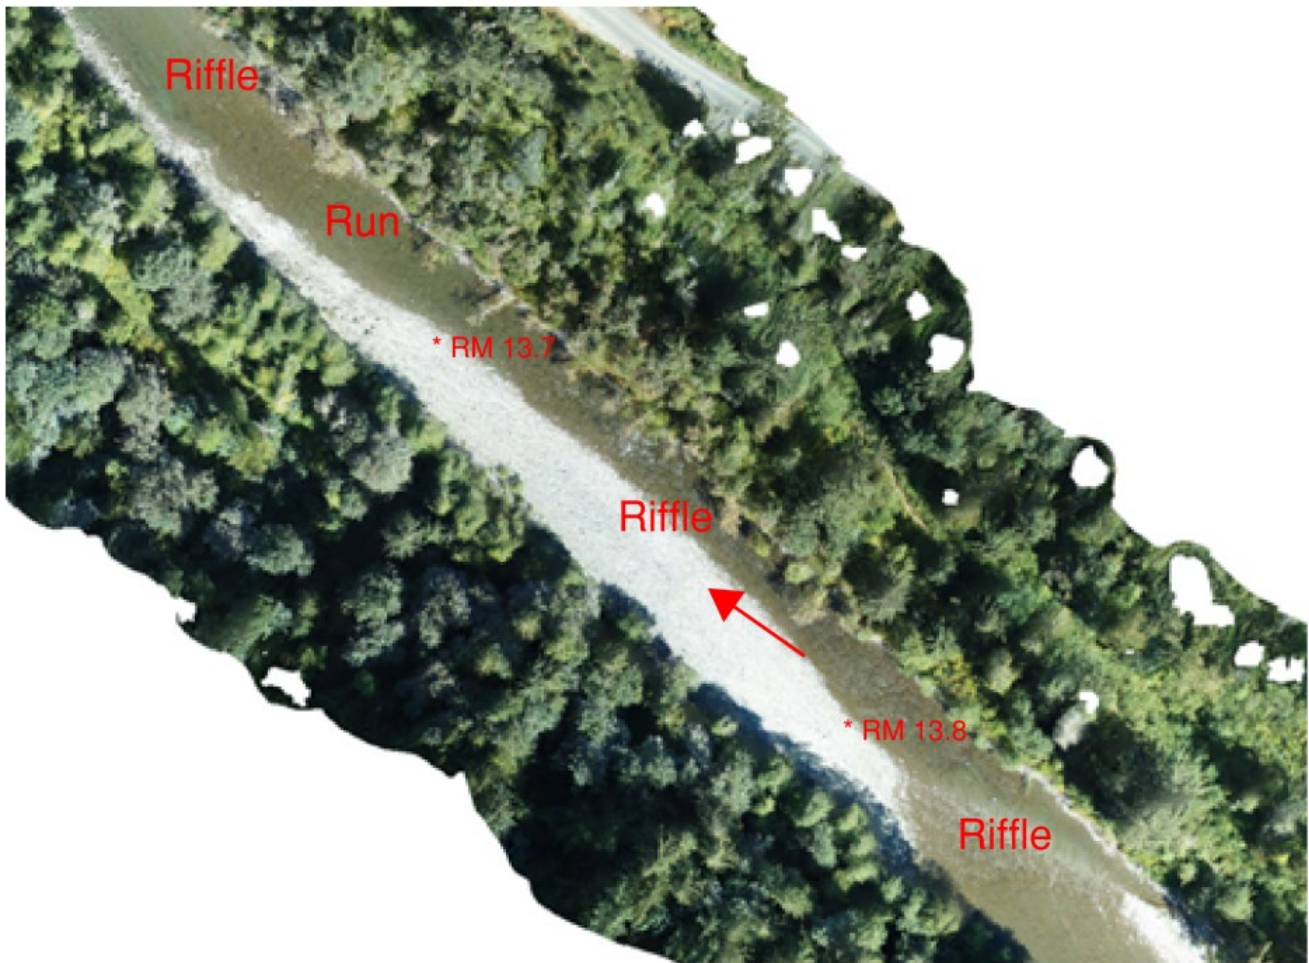
Figure 3. Phase 3 Sub-Reach 2 (RM 13.85–RM 13.65).

Sub-reach 2 includes only riffles and runs; no pools are present (Figure 3). No bank armoring is present and both banks are vegetated with native trees and shrubs. A large left bank gravel bar directs lower flows towards the right bank. This sub-reach is considered a high energy area based on the hydraulic model results; therefore, there is a good potential to use ELJs to slow flow velocities, encourage channel aggradation, create deep and complex pools and improve channel planform complexity. Sub-reach 2 has a gradient of just under 0.5 percent slope and would support a more frequent pool-riffle sequence with the placement of larger LWM structures to induce more complex bedform and planform variability.

- Multiple medium and large (35 to 50 feet wide/1,225 to 2,500 sf) ELJs can be spaced along the right bank low flow channel. This configuration will encourage development of complex habitat units (pools, riffles and runs) between the ELJs.

- Multiple medium ELJs can be spaced along the left bank opposite of, and between, the right bank ELJs. Alternating the left bank and right bank ELJs in this manner will encourage flow to “zig zag” between the structures. This planform complexity and variability will help to slow flow velocities and encourage sediment to deposit locally thereby aggrading the incised channel to increase floodplain activation.
- Multiple small ELJs and individual large LWM pieces can be placed mid-channel between the bank ELJs to provide more instream LMW and encourage formation of complex mid-channel habitat features.

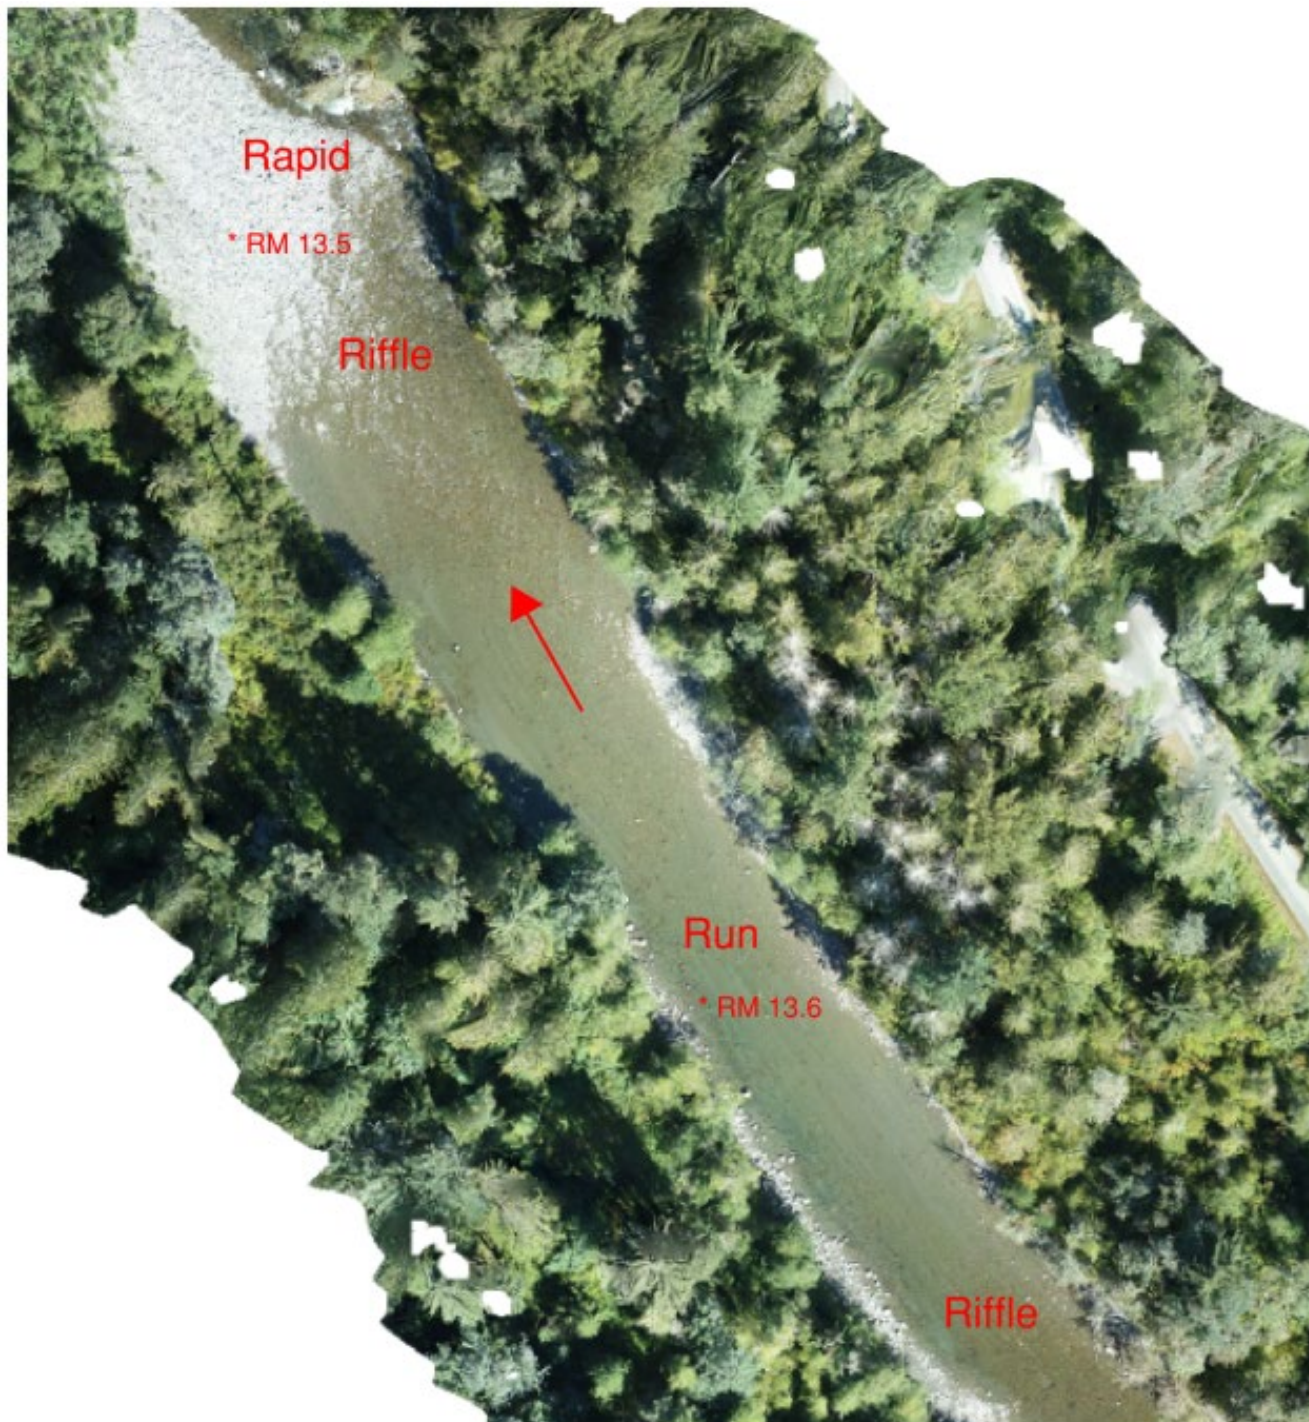
Figure 4. Phase 3 Sub-Reach 3 (RM 13.65–RM 13.50).

Sub-reach 3 consists primarily of a long, wide and shallow run with short riffles at the upstream and downstream side. No pools or bank armoring are present and both banks are vegetated with native trees and shrubs. The main channel has migrated away from the bedrock valley wall and there is a remnant left bank valley wall channel that is only activated at higher magnitude floods (i.e., 10-year floods and higher). Significant aggradation would be required in this reach to activate the left bank valley wall channel at meaningful flows (higher frequency) to support a frequently inundated side channel and will probably only provide high flood refugia even after restoration unless the restoration efforts are very aggressive with promoting extensive aggradation (i.e., valley-spanning structures). This sub-reach is also considered a high energy area based on the hydraulic model results; therefore, there is a good potential to use ELJs to slow flow velocities, encourage channel aggradation, create deep and complex pools and improve channel planform complexity.

- Small and medium ELJs can be located along both banks in an alternating pattern to encourage flow to “zig zag” between the structures. This will help to slow flow velocities and encourage sediment to deposit locally thereby aggrading the incised channel to increase floodplain activation.

- Medium and/or large ELJs can be located along the right bank and mid-channel near the downstream end of this sub-reach to help direct flow into a relic left bank side channel that begins near RM 13.50 that can be regraded to provide off-channel habitat as described in Sub-reach 4 below and as shown in Figure 4. These ELJs will also provide functions similar to the small and medium bank ELJs described in the previous bullet.

- Multiple small ELJs and individual large LWM pieces can be placed mid-channel between the bank ELJs to provide more instream LMW and encourage formation of complex mid-channel habitat features.

- Some left bank activation may be beneficial for habitat refugia for larger events near the downstream portion of the sub-reach. This may be valuable high flow refugia because floodplain connectivity is so limited in this sub-reach and the left bank is one of the few off-channel habitat opportunities.

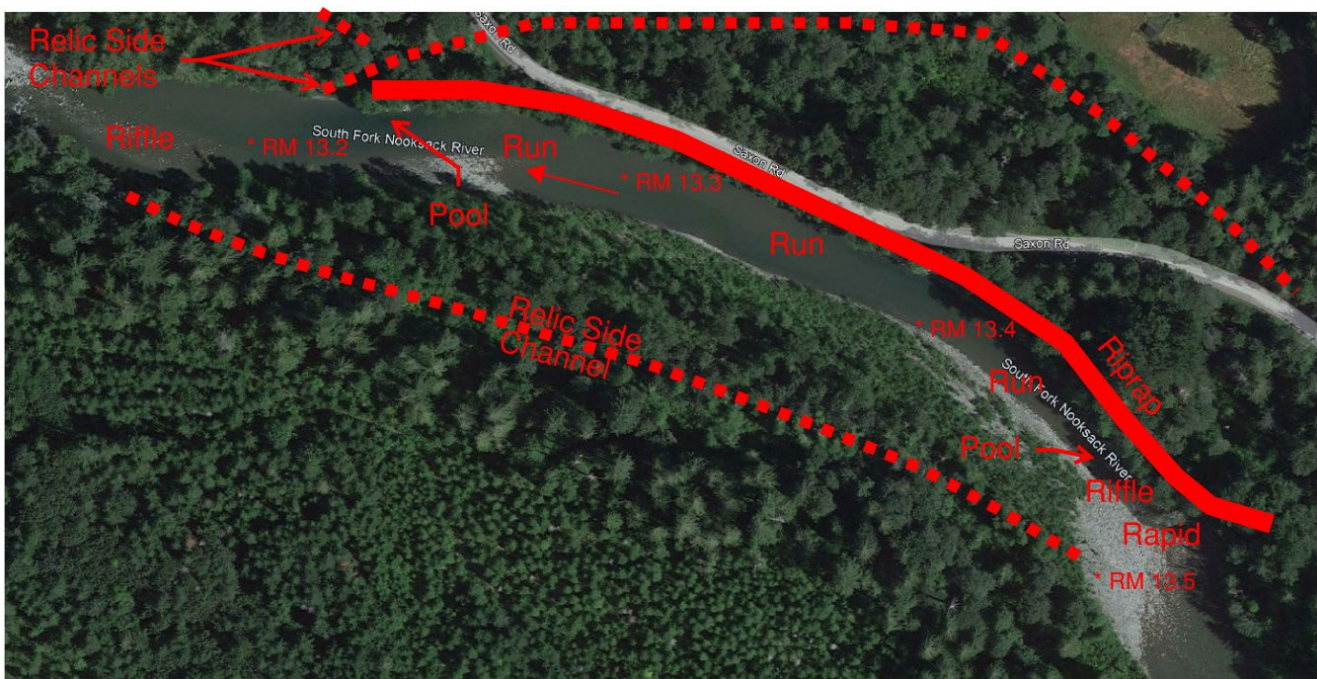
Figure 5. Phase 3 Sub-Reach 4 (RM 13.50–RM 13.20).

At the upstream end of Sub-reach 4 at RM 13.50 is a very short and steep rapid that quickly transitions to a short riffle then to a very small and shallow secondary pool. This pool quickly transitions to a very long, deep and slowly flowing run for most of the remainder of the sub-reach with a second bigger and deeper secondary pool at the downstream end of the sub-reach (Figure 5). Adult salmon migrating upstream will hold in both pools before ascending upstream. The channel is aligned parallel to Saxon Road for about half of the run. Riprap is present along most of the right bank between the top and toe of the bank to prevent further channel migration towards the roadway and the channel is entrained along it. This sub-reach is also a high energy environment; the channel is predominantly confined between the riprap and the left bank of the floodplain, and it is significantly incised downstream of the rapid. This is the result of a headcut that has propagated upstream in part because of the incision. A relic right bank high flow channel located in the vegetated right bank floodplain landward of Saxon Road crosses under the road via an 18- to 24-inch-diameter culvert and converges with the main channel at the downstream end of the riprap. Upstream migrating adult salmon will also hold in a deep section of the run at the downstream end of the riprap. Along the toe of the left/south bank valley wall is another relic, high flow floodplain side channel that has filled in with fine sediments and become overgrown with native trees and shrubs. This is due to the floodplain becoming disconnected with the main channel because of the incision. The floodplain between the valley wall and the main channel consists primarily of young native deciduous trees and shrubs.

- Multiple large ELJs can be spaced along the armored right bank to cover the riprap, create deep and complex pools, and dissipate flow energy to encourage sediment retention and begin reversing the effects of channel incision. A secondary benefit of these ELJs is that they can work in concert with the riprap to provide additional protection to the roadway while significantly improving habitat conditions. The ELJs can either be constructed into the bank by removing the riprap (and reusing it to ballast the structure) or the riprap can remain and the ELJs built completely landward of it. Riprap between the ELJs would not be disturbed. In lieu of multiple large ELJs, the riprap bank can be roughened by supplementing it with large logs and other smaller woody material; however, this will likely require disturbing much of the existing riprap and rebuilding the entire bank to secure the logs. Habitat improvements for this scenario would be considerably less than if ELJs were constructed.

- The main active channel along the riprap is much narrower and deeper than the main channel elsewhere in the Phase 3 reach due to the aforementioned incision; therefore, the large ELJs, by virtue of their size, will project into the channel approximately one-third to one-half of the channel width. This configuration will deflect flow towards left bank vegetated gravel bar inducing substantial, and much needed, localized bank erosion and bed scour. This will likely cause a significant rise in WSEs for a wide range of high flows (2-year flood and greater, including the FEMA regulated 100-year flood) before the bank can naturally erode, in response to the ELJs, to provide greater hydraulic conveyance and lower WSEs. Therefore, to mitigate the potential WSE rise and expedite bank erosion, the left bank of the gravel bar opposite of the ELJs and the riprap can be regraded in such a way to mimic the bank erosion that would occur there naturally to provide greater flow conveyance to help offset the potential WSE rise.

- The existing relic left bank side channel can be regraded to significantly increase activation and provide off-channel habitat. Increasing flow into this side channel will help to keep it open and result in less flow in the main channel, which will help to offset potential WSE rises and encourage sediment retention within this sub-reach to begin reversing the effects of channel incision. Small ELJs and LWM can also be placed in the side channel to provide habitat complexity.

- Alluvium removed as part of the left bank regrading and any surplus alluvium from ELJ construction and left bank side channel regrading can be regraded around the bank ELJs to keep the valuable alluvium in the system and available for downstream redistribution to address the channel incision. Finer alluvium and floodplain material can be placed over the riprap remaining between the ELJs. Topsoil and mulch can be placed over the finer alluvium and floodplain material, and over the tops of the ELJs, to provide a suitable substrate for riparian plantings to improve edge habitat conditions between the ELJs. This will also significantly improve the aesthetics of this area. Redistributing the excavated alluvium material and placement of the finer alluvium material and floodplain soils to cover the riprap will also help to reduce construction costs.

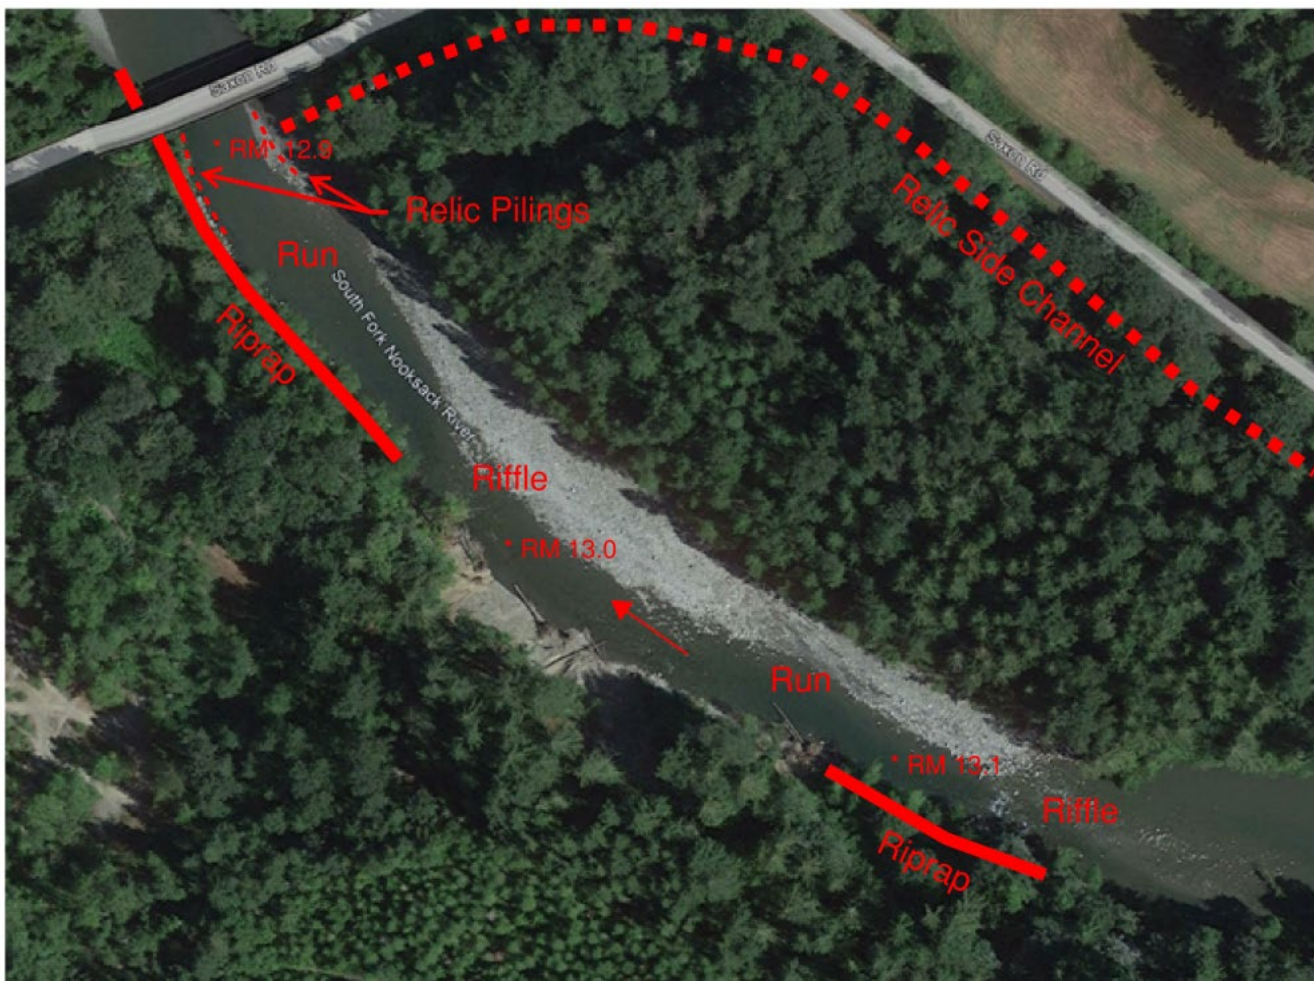
Figure 6. Phase 3 Sub-Reach 5 (RM 13.15–RM 12.90).

Sub-reach 5 includes two riffle-run sequences with no pools before reaching the Saxon Road Bridge with two discontinuous sections of riprap present along the left bank (Figure 6). Relic wooden pilings from previous bridges are also present near the current bridge. The channel is aligned along a steep eroding bluff in the vicinity of RM 13.00 that occasionally provides small transient woody debris to the channel. Riprap was likely present along the toe of the eroding bluff, thus making for a continuous revetment along the left bank to protect the current and past bridges, but it was likely lost due to bank erosion. The right bank floodplain is heavily vegetated primarily with second growth conifers and contains a relic high flow side channels that is aligned parallel to Saxon Road. This sub-reach is considered a high energy area based on the hydraulic model results; therefore, there is a good potential to use ELJs to slow flow velocities, encourage channel aggradation, create deep and complex pools and improve channel planform complexity.

- Medium and large ELJs can be located along the left bank to create deep and complex pools and to catch trees recruited into the river from the eroding bluff. When combined with the small and medium ELJs along the right bank (see next bullet) they can function collectively to dissipate flow energy to encourage sediment retention and begin reversing the effects of channel incision through this sub-reach. Channel aggradation in this sub-reach and in Sub-reach 4 upstream will increase the activation frequency of the relic right bank side channel thereby improving floodplain connectivity and off-channel habitat.

- Multiple small and medium ELJs can be spaced along the right bank at the edge of the vegetation and along the large right bank gravel bar to provide woody cover and improve channel bed complexity.

- The upstream segment of riprap near RM 13.10 can be removed to allow channel migration into the steep bluff to encourage recruitment of trees into the channel and to restore natural bank conditions that will significantly improve edge habitat. The downstream segment of riprap and relic pilings along the left bank should not be removed as doing so will increase risk to the bridge, which is maintained by Whatcom County. However, ELJs can potentially be placed in the channel near the riprap to mitigate the adverse effects of it on habitat but only if they do not increase risk of failure to the riprap and pilings.

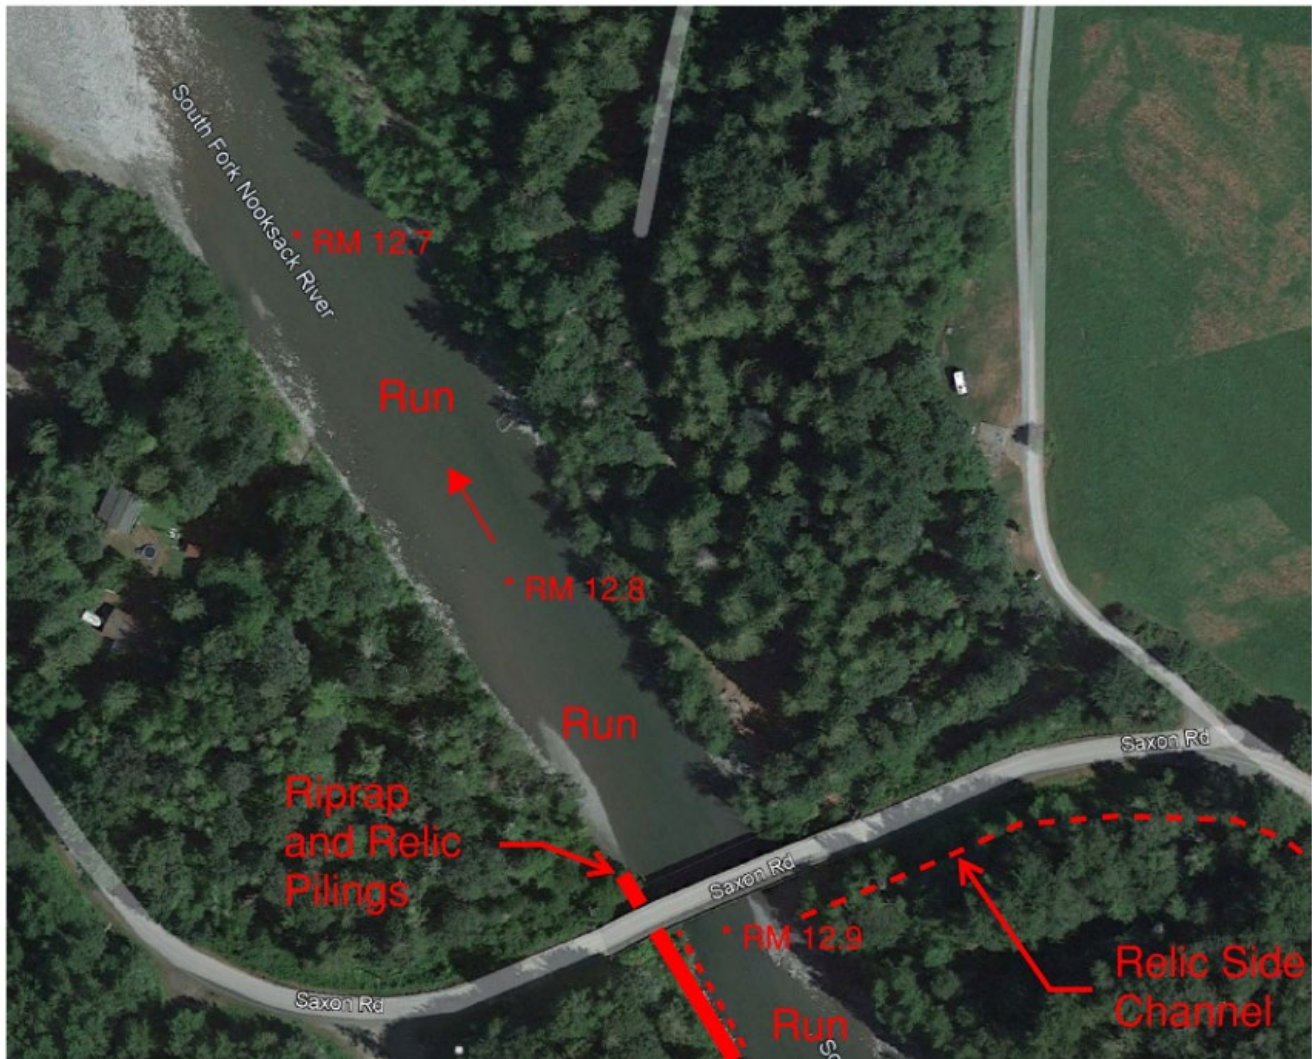
Figure 7. Phase 3 Sub-Reach 6 (RM 12.90–RM 12.70).

Sub-reach 6 consists of one long, wide and shallow run with no pools or other notable instream habitat features (Figure 7). Bank vegetation consists of a mix of coniferous and deciduous trees and shrubs. This sub-reach is considered a high energy area based on the hydraulic model results; therefore, there is a good potential to use ELJs to slow flow velocities, encourage channel aggradation, create deep and complex pools and improve channel planform complexity. This sub-reach terminates at the Saxon Reach Habitat Restoration project of 2012, insinuating an opportunity to link the two projects.

- Multiple small and medium ELJs can be spaced along the left and right banks and mid-channel to create deep and complex pools, provide woody cover and improve channel bed and planform complexity. This reach is likely sensitive to WSE rise with residences on the left bank, so these ELJs should target small and localized hydraulic complexity for lower flows but not for higher flows (i.e., ELJs should have a low profile so that larger flows skip over them). Privately owned, mostly unoccupied floodplain is on the right bank, therefore landowner outreach on both banks will guide restoration opportunities.
