# Nooksack River Instream Project Effectiveness

April 2020

**Contributing Authors:** Michael Maudlin, Nooksack Tribe; Alex Levell and Nathan Rice, Lummi Nation

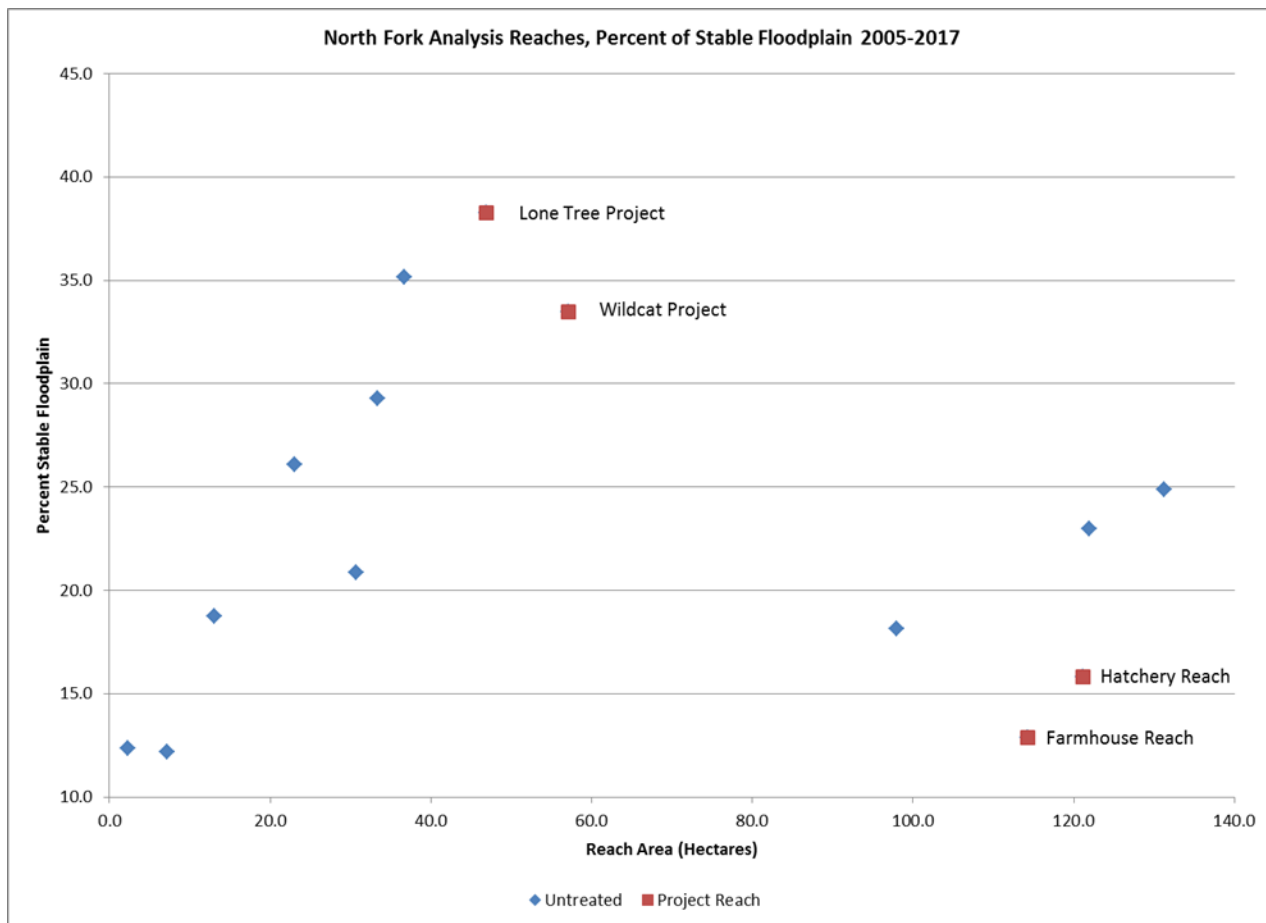
**Figure 10: Percent of stable floodplain (defined by continuous tree growth) for the North Fork Nooksack analysis reaches between 2005 and 2017. Orange boxes show project reaches treated during that timeframe. The Farmhouse project was initiated late in the monitoring period. Reaches with the largest area are generally less confined than that the reaches with less area.**

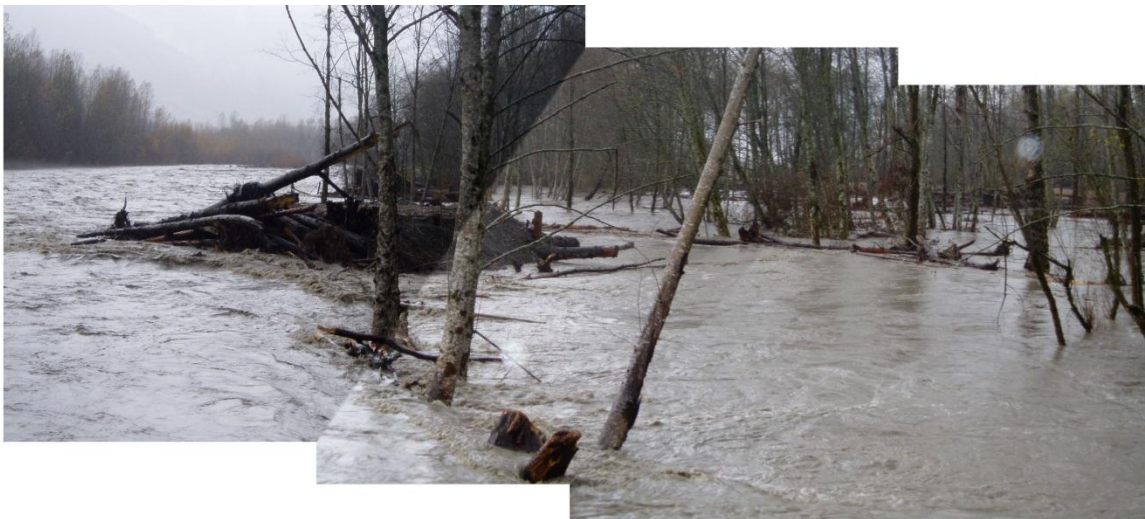
**Figure 94: Looking downstream at Logjam #4 in the floodplain during the November 6, 2006 flood.**

During November of 2006, the South Fork Nooksack experienced a ~10,000 cfs (mean daily discharge) flood. This was slightly larger than a 2-year flood event on the river. During this event, the entire floodplain in the project areas was inundated more than a meter deep (Figure 93, Figure 94), similar to the results shown for the Nasset's Project existing conditions modeling that included this reach. During the flood, the high velocity of the channel remained in the active channel area on the outside of the three water-ward logjams, while immediately behind the logjams the water was nearly still. The logjams provided an effective barrier to high velocity, while allowing floodplain inundation.

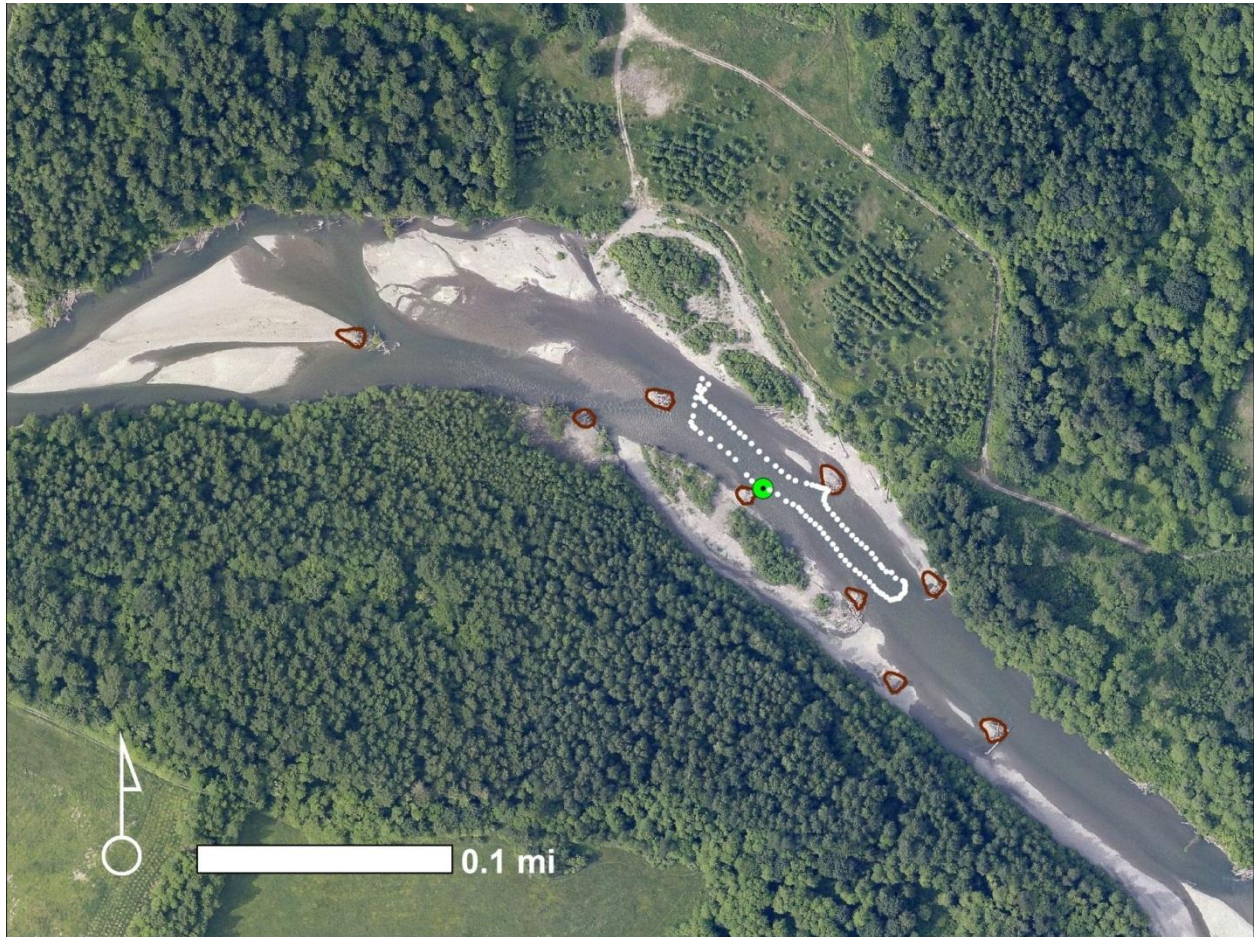
Figure 105: Thermal profile of the Downstream of Hutchinson Project in August of 2013. Note the thermal anomaly at ~320m showing ~2°C temperature difference during the warm part of the day (Gendaszek 2014).

A second method of evaluating stream temperature was used in the project reach that allows both a picture of the spatial distribution of temperature and how it changes through time (Gendaszek 2014). The distributed temperature sensor (DTS) is a fiber optic cable that is placed along the bed of the river that can record a continuous temperature profile along its length. The cable was installed so that it captured the areas adjacent to four of the logjams as well as the river between the sites (Figure 104). The cable recorded temperature for approximately a week during August of 2013 and found that there was one location where there was a cooler water anomaly, at approximately 320 m along the temperature profile (Figure 105). Habitat mapping in the reach in 2013 showed that most of the area that was monitored was a large, shallow riffle habitat, with secondary pools near four of the structures and a fifth pool at a natural woody debris pile (Figure 106). The site of the anomaly was a 1.2 m deep secondary pool associated one of the engineered logjams. The other pools associated with the logjams that were monitored showed no cooling in spite of also being similar habitat types and having similar depths.
