Death at the End of a Hose

How one man's honest mistake cost another man his life, and grief for several companies.

BY STEVEN M. BARSKY

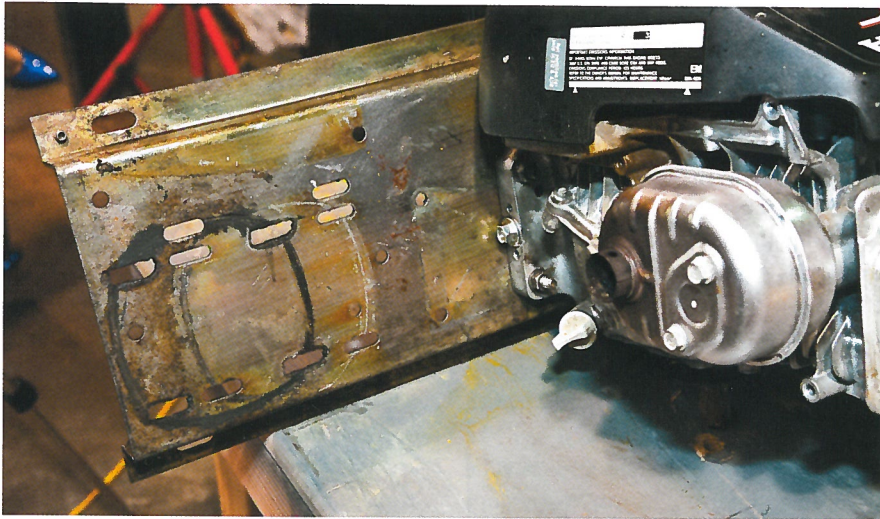
Once the compressor was removed from the frame, it became apparent that the compressor had been moved from its original location and that someone had hand cut new mounting holes for the bolts that secured the compressor. Note the irregular slots in the frame and the outline of the compressor base ringed in oil, as well as the previous location of the compressor.

During the course of the lawsuit, experts from both sides of the case disassembled the hookah system. Upon disassembly it was discovered that the frame the system was mounted on had numerous holes in it that appeared to have been cut with a hand saw. These hand cut holes were obviously used to change the mounting location of the compressor, since the outline of the previous compressor location could be seen on the frame once the system was taken apart. It also became apparent that in addition to having the wrong type of engine and an insufficient length compressor intake,

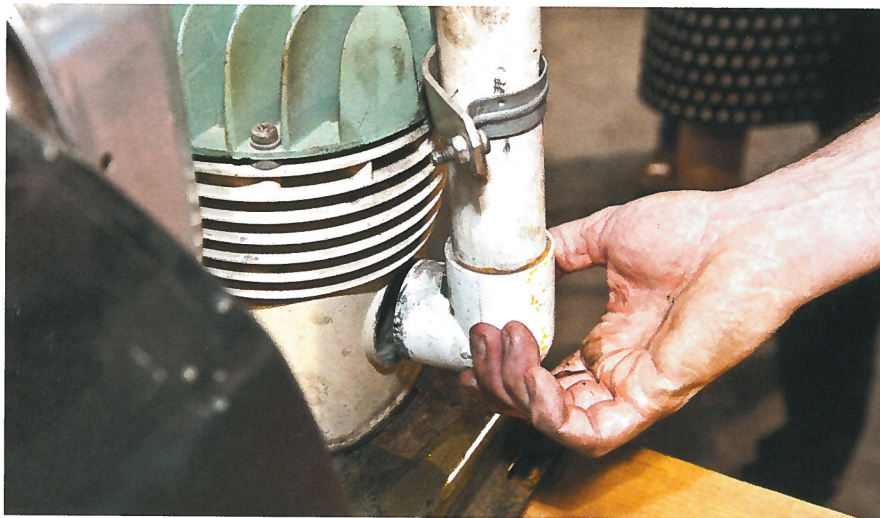
The connection between the snorkel and the compressor was not secure, which would allow carbon monoxide to freely enter the compressor.

i.e. “snorkel,” the connection between the snorkel and the compressor was not secure, allowing carbon monoxide to freely enter the compressor.

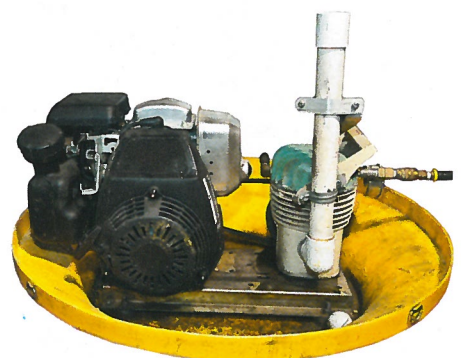
The hookah diving system that was provided by the golf ball diving company to the diver who died.

When the engine on Mike's hookah system died, he purchased a new one from a hardware store, without giving it too much thought. After all, all small engines are alike, aren't they? Unfortunately not, for although their footprint was identical, the engine exhaust on the new engine was located on the opposite side when compared to the prior engine used in the system. This placed the exhaust for the engine less than twelve inches away from the compressor intake.

compression of carbon monoxide along with the diver's breathing air. The snorkel on his compressor was missing an extension piece, which he may not have even realized needed to be there. In addition, Mike had never bothered to have the air from the compressor tested for purity.

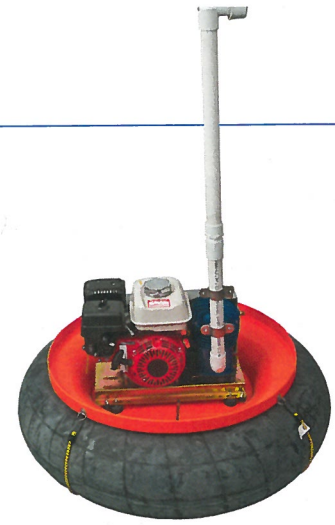
A properly configured hookah diving system looks like this. Note the tall white air intake or “snorkel” used to provide air to the compressor. This type of system is not considered acceptable for commercial diving under ADCI standards.
