Road Safety Audit

Lummi Nation Reservation

August 2017 H-U0630.00 Final

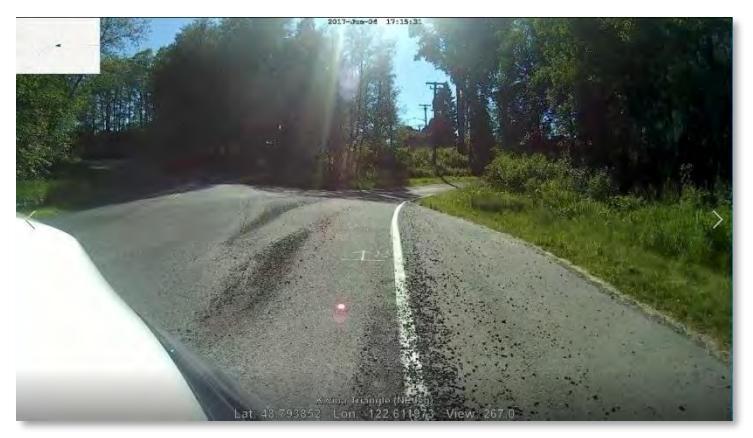
Figure 13 - Westbound Approach turning Northbound

Kwina Rd, Marine Dr, Lummi Shore Dr, and Lummi Shore Rd form a triangular series of intersections in a relatively small area. To further complicate things, there is a significant grade differential in the area and mature tree growth in the center of the triangle, further restricting sight distance. During field observations, other drivers regularly hesitated on several approaches, not always sure which vehicle was to be given the right of way. This was observed despite the stop signs which provide this guidance. Additionally, the significant skew associated with the northern, southern, and eastern intersections may make it more difficult for approaching drivers to look for oncoming or cross traffic. Figure 13, Figure 14, and Figure 15 provide the view of this location from several approaches and angles.

Given relatively high speeds (posted 35mph limit with observed speeds around 45mph along Marine Dr) the grade differential, curves, and other intersecting roadways, this location experienced ten collisions from 2011 through 2016. Figure 16 illustrates the number, type, and severity of the reported collisions. As shown in the figure, run off road collisions are the most frequent followed by left turn head on collisions. Several resulted in injuries with the majority occurring under dry road conditions.

While a long-term countermeasure is already programmed, there are several short-term, low-cost suggestions which might help to improve operations at this location in the meantime. One recommendation is the restriping of the center and edge lines along the main route (Marine Dr to Lummi Shore Rd) to help reduce confusion. Alternatively, the installation of chicken tracks / guidance markings could provide additional guidance for drivers navigating through the intersections. Figure 18 provides an example of these treatments.

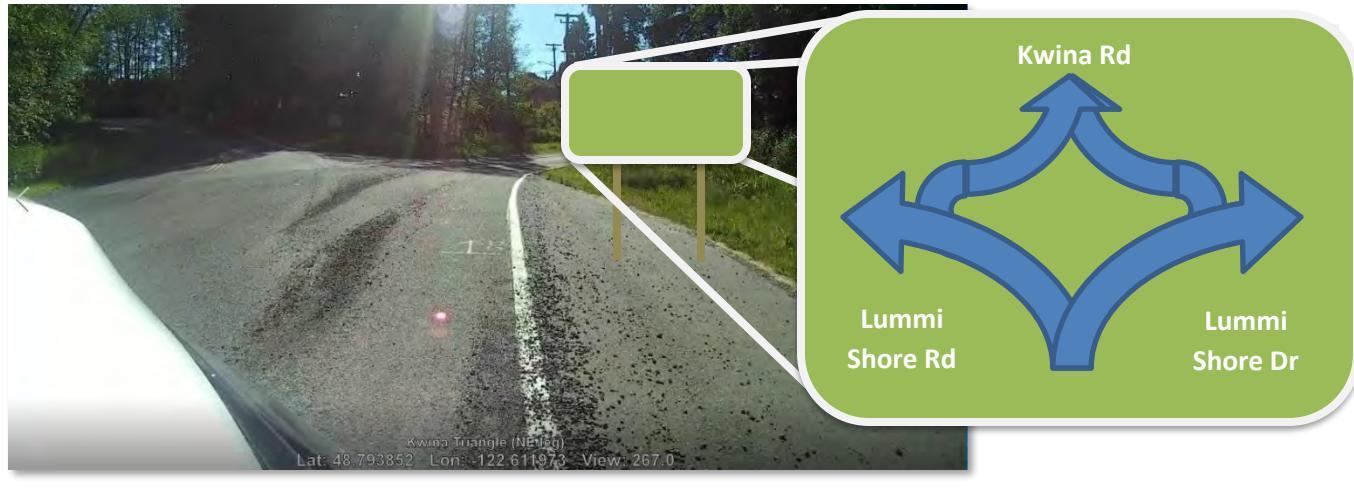
Figure 19 - Mock Guidance Sign – Westbound Approach

An additional short-term, low-cost recommendation is the installation of guidance signs on approaches to the area. These would provide drivers with information regarding the correct direction of travel through the series of intersections, potentially reducing confusion and hesitation. Figure 19 provides a typical guidance sign as well as an example of what such a sign might look like on one of the approaches.

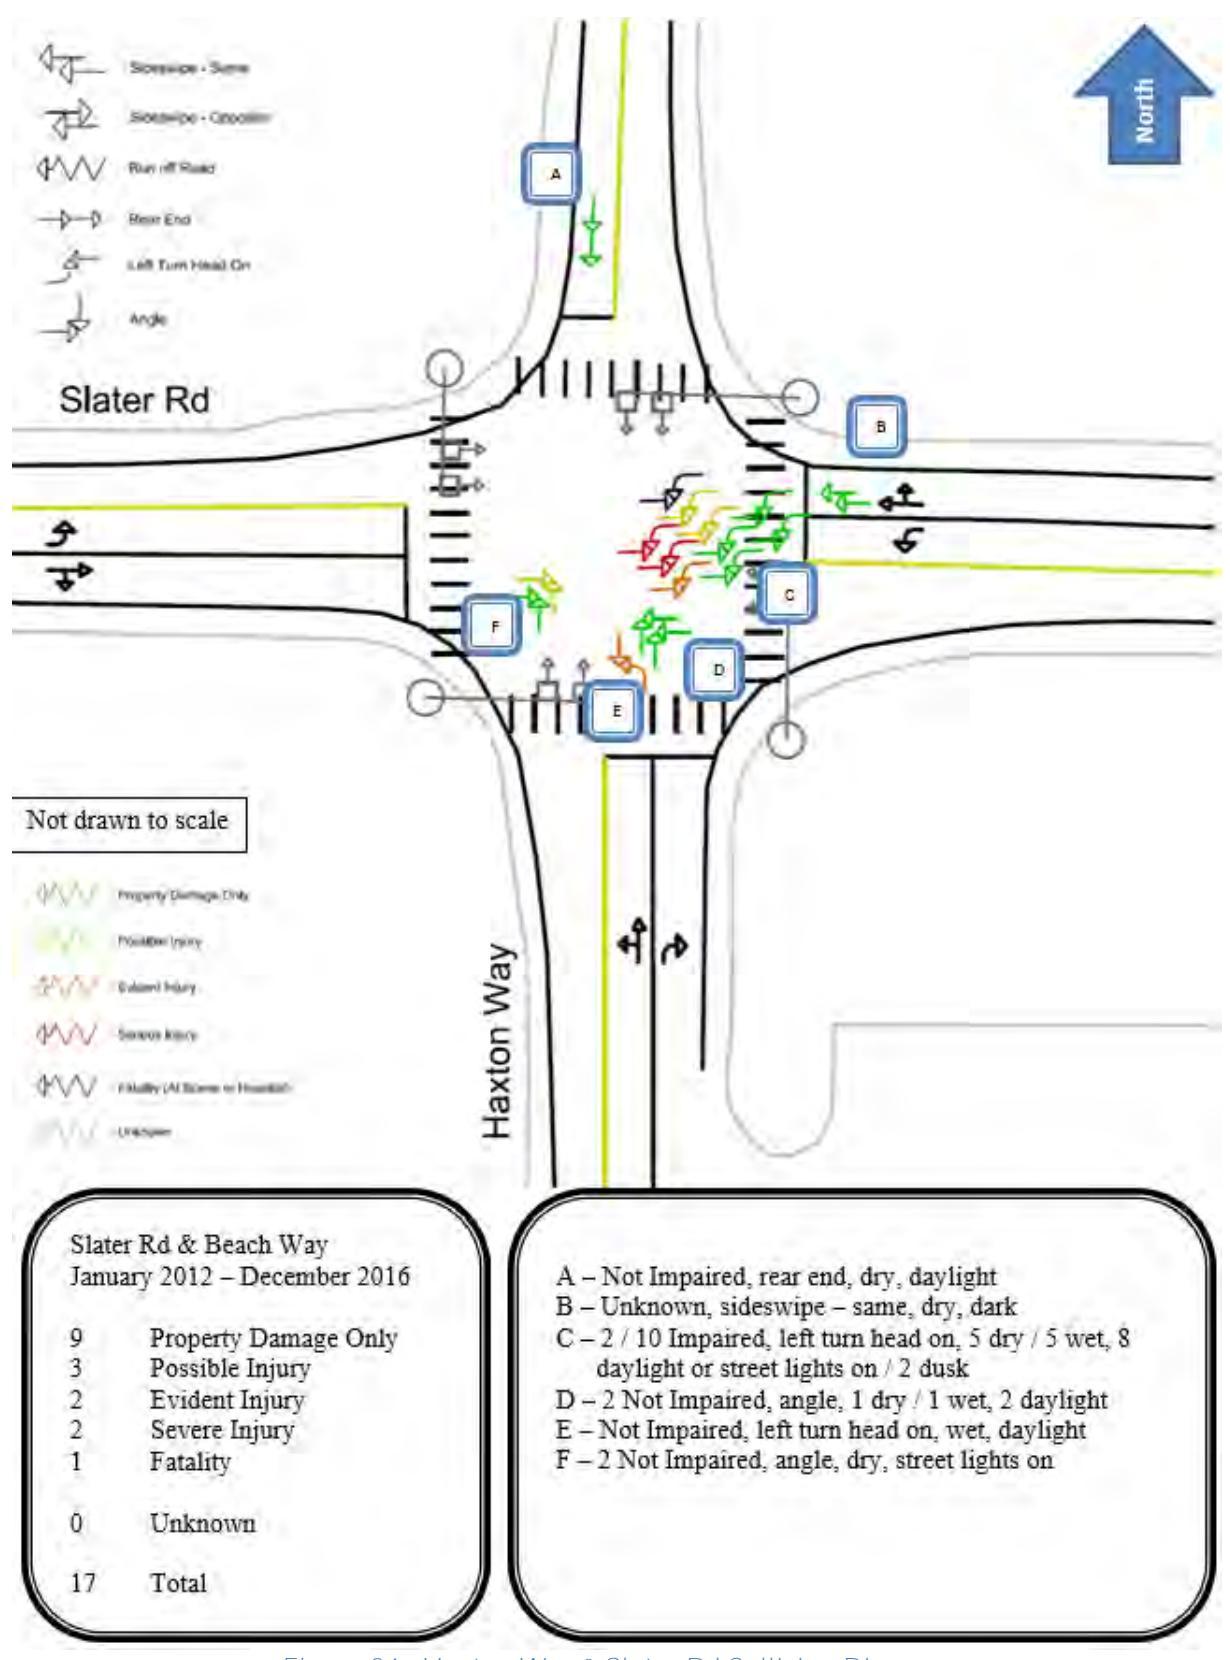
Figure 24 - Haxton Way & Slater Rd Collision Diagram

The collision diagram for this location is provided in Figure 24, and shows the lane use for each approach. As shown in the diagram, the majority of collisions at this location consist of left-turn headon collisions along Slater Rd. Operations were reviewed at the intersection but no significant issues were observed with the traffic signal timing which would suggest any contributing factors related to the collision pattern.

Given the significant portion of angle and left turn head on collisions at this location, there may be cause to convert the signalized intersection to a roundabout. This would virtually eliminate the potential for these types of collisions and help regulate speeds in the area. Typically, roundabouts experience an increase in the number of property damage only crashes along with a significant reduction in fatal and injury crashes.

Given the significant portion of westbound left turn head on collisions at the intersection, there may be cause to implement a protected westbound-to-southbound left-turn movement. This would provide drivers making the left turn from Slater Rd onto southbound Haxton Way a dedicated period of time to complete the maneuver while no conflicting traffic is present. This should reduce the potential for left-turn head-on collisions at the intersection, which represent both the greatest number of historic collisions here as well as the most severe.

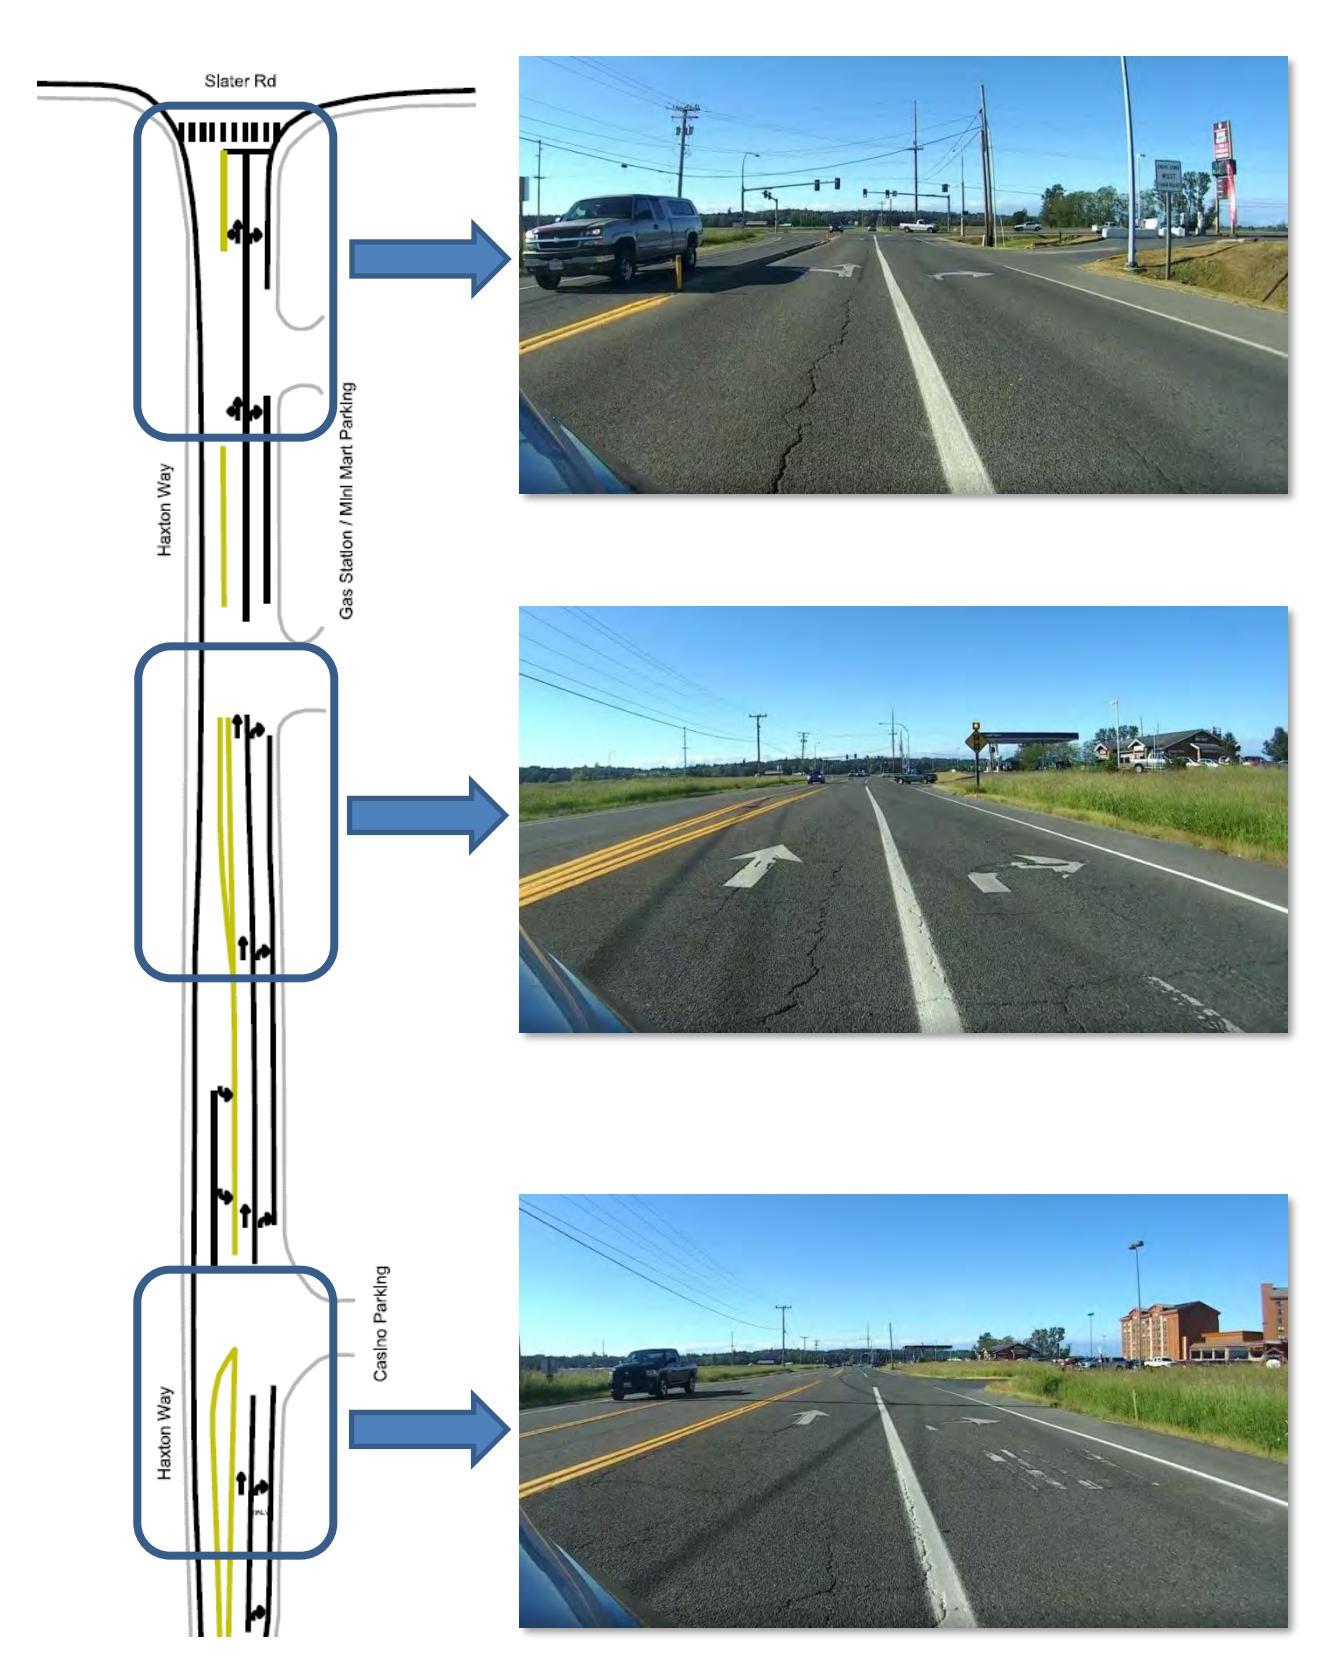
Figure 25 - Northbound Haxton Way Right Turn Lane

Additional concerns were raised regarding the placement and pavement marking layout for the northbound right turn lane. This portion of the facility services the casino, the gas station, and finally the intersection itself. The current pavement marking layout technically restrict those points where drivers are permitted to enter the turn lane. It was noted that there is confusion among drivers regarding when to turn into the lane depending on which turn they ultimately intended to take. This has resulted in several near misses and was raised as a concern during the kick-off and subsequent meetings. Figure 25 provides a view of this approach.

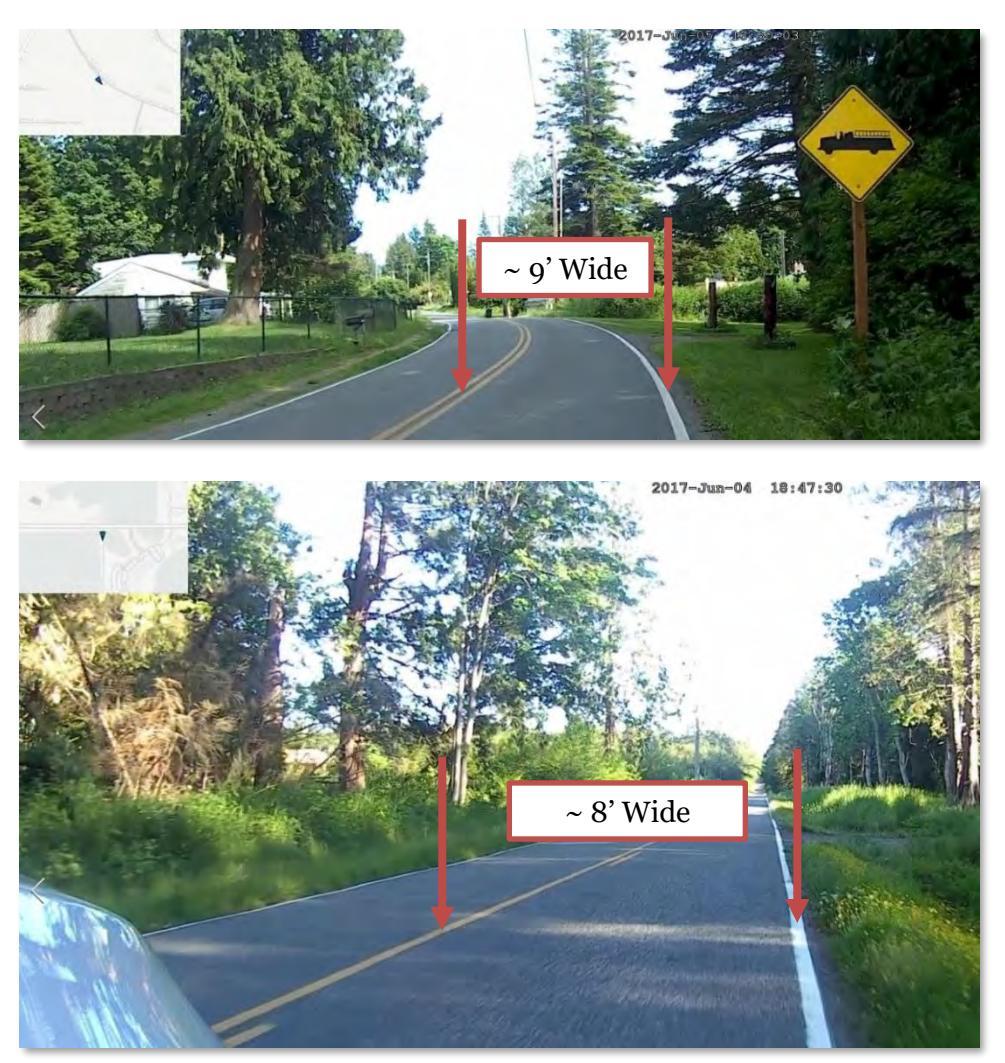
Figure 28 - Example Lane Widths (Mackenzie Rd, Top, and Chief Martin Rd, Bottom)

Most of the roadways throughout the Reservation were noted as having relatively narrow lane widths and / or no or limited shoulder area. These issues increase the potential for sideswipe-opposite direction collisions as well as run off road collisions. These issues may be compounded along hilly or curve segments of roadway where the driver is taxed more significantly in the guidance and navigation tasks associated with driving. Figure 28 provides some example locations where narrow lanes and / or shoulders were observed, along with any measured lane widths.

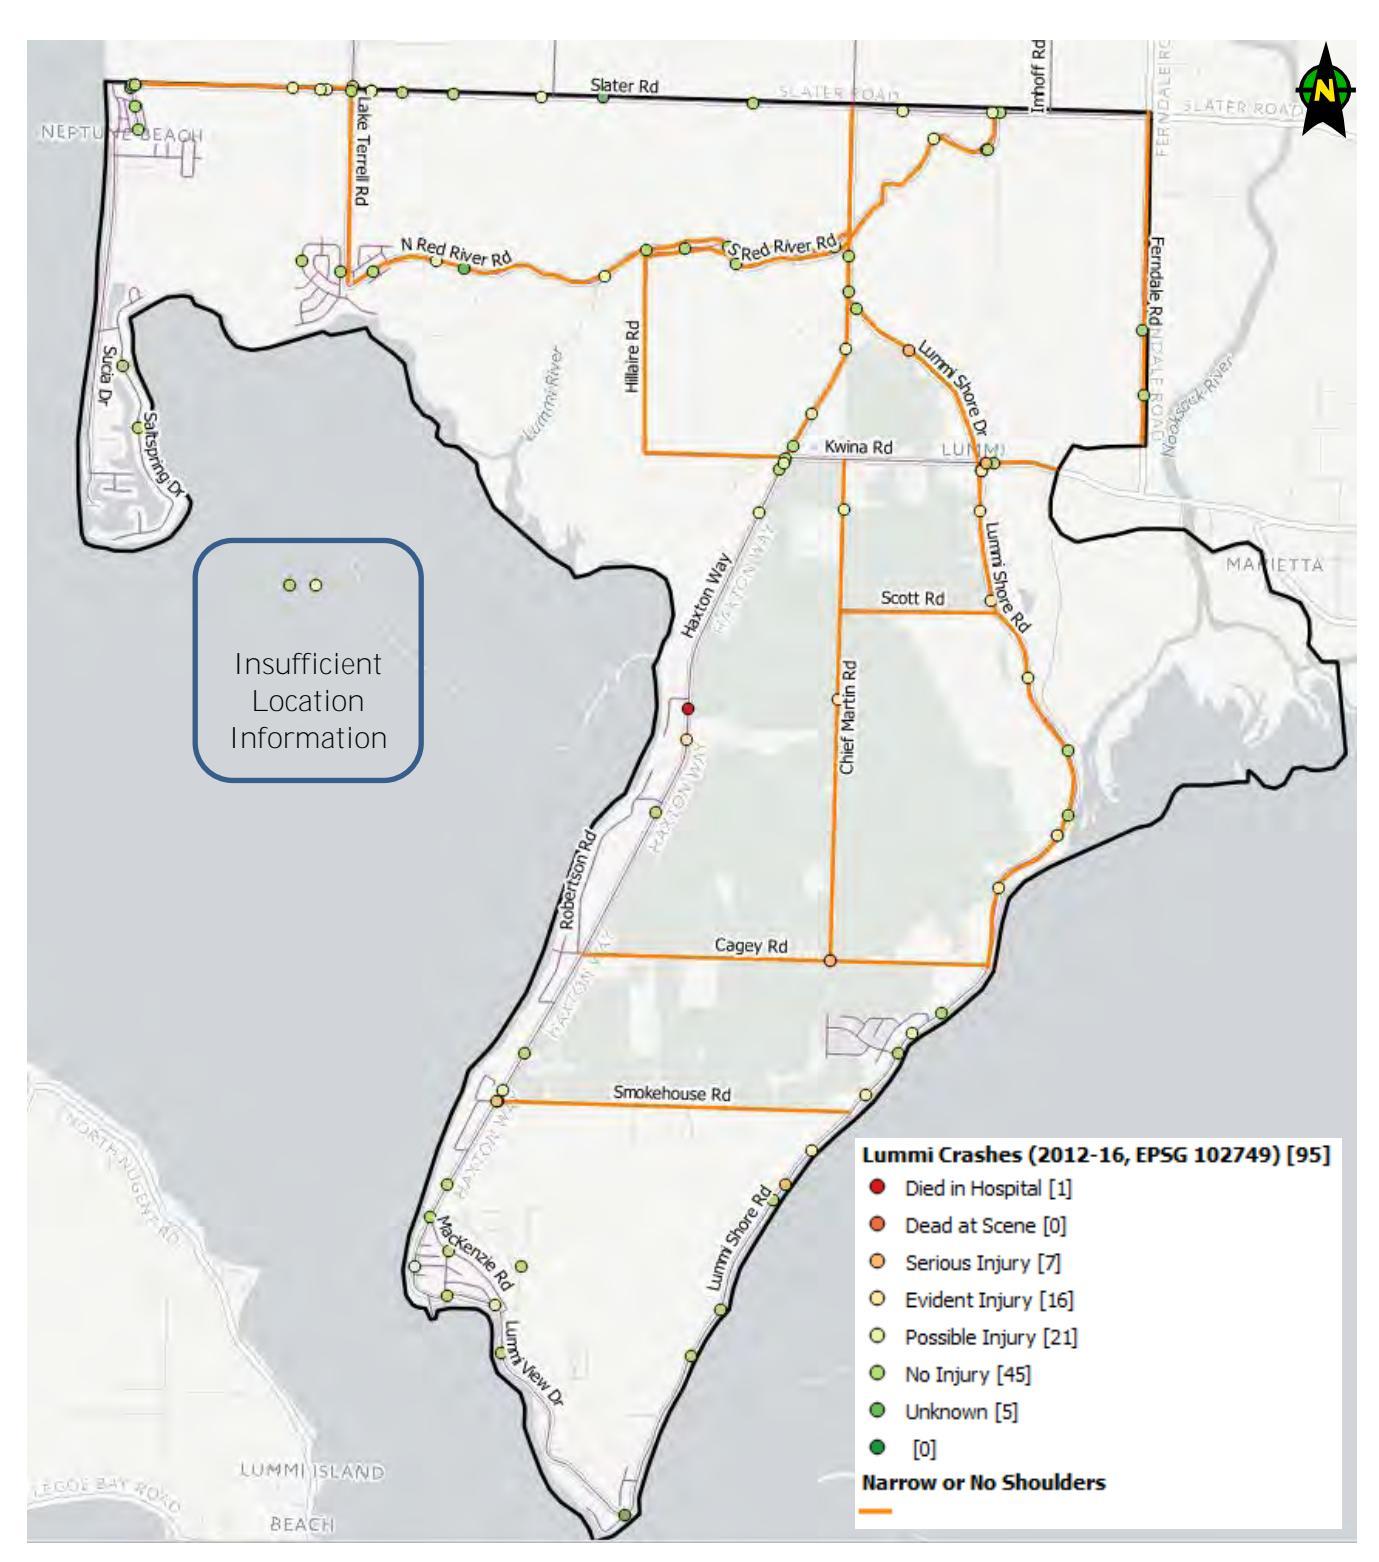
Figure 29 - Run off Road Collisions & Potential Paved Shoulder Locations

Areas where these align (i.e. high collision location where right of way is available or easements are feasible that are not obstructed by structures or sensitive environmental areas) may be good candidate locations of the widening of travel lanes or the addition of paved shoulders. These have been shown to help reduce the potential for sideswipe-opposite, head on, and run off road collisions. Figure 29 provides the location and severity of typical run off road collisions (fixed object, overturn, etc.) which were reported on the Reservation during the study period. Roadways with narrow or no shoulder have been highlighted in the figure where existing geometric restrictions do not already preclude the addition of paved shoulders, providing locations for potential improvements.

Based on the existing geometry, traffic volumes, and the results of the HSM analysis, the segments highlighted in Figure 29 are expected to collectively experience approximately 2.42 collisions annually. Based on the historic reported collisions at this location, the intersection has only experienced an annual average of 2.2 collisions per year, meaning this location is currently performing better than would be expected. Table 9 summarizes the estimated impacts of the recommendations listed previously. It must be noted that those recommendations lacking collision modification factors (CMF) or those which do not apply to all collision types of all severities cannot be tested in the analysis and have been omitted.

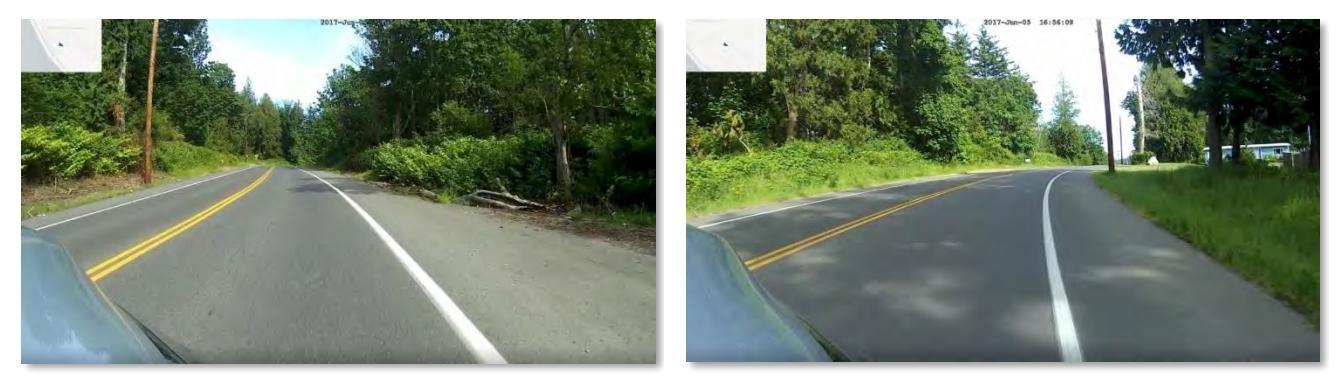
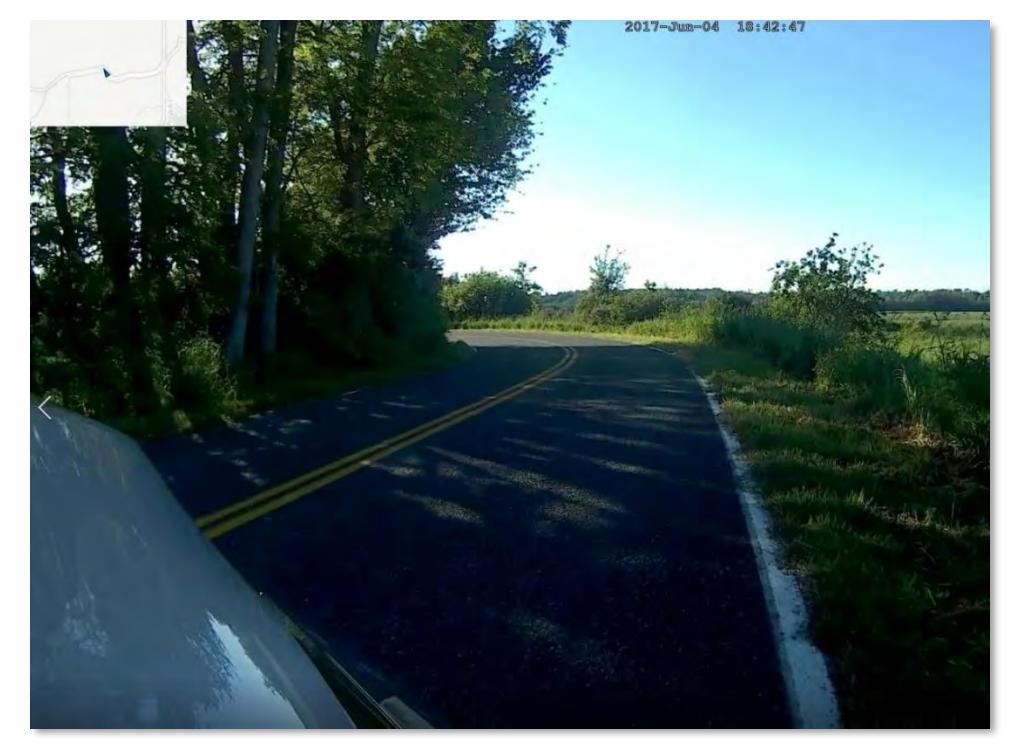
S Red River Rd Blind Curve Figure 30 - Unmarked Curve Examples

Given the hilly and sometimes winding nature of portions of the road network, several curves were identified within the Reservation. Many of the curves observed during the field review did not have advanced curve warning signs or chevrons and other delineation through the curve itself. These locations may have an increased risk for run off the road collisions, sideswipe-opposite, or head on collisions. This may be especially true during the summer months with increased numbers of tourists and visitors who may not be as familiar with the local area. Figure 30 provides examples of unmarked curves identified within the Reservation.

Lead into Curve

Additional chevron signs and target arrow signs could be installed along the curve itself to help highlight the roadway geometry. These could be supplemented with retroreflective strips along the sign posts, LED lights, or other beacons depending on the severity of the curve. Figure 33 provides an example of some existing curve treatments **along Lummi's roads**.

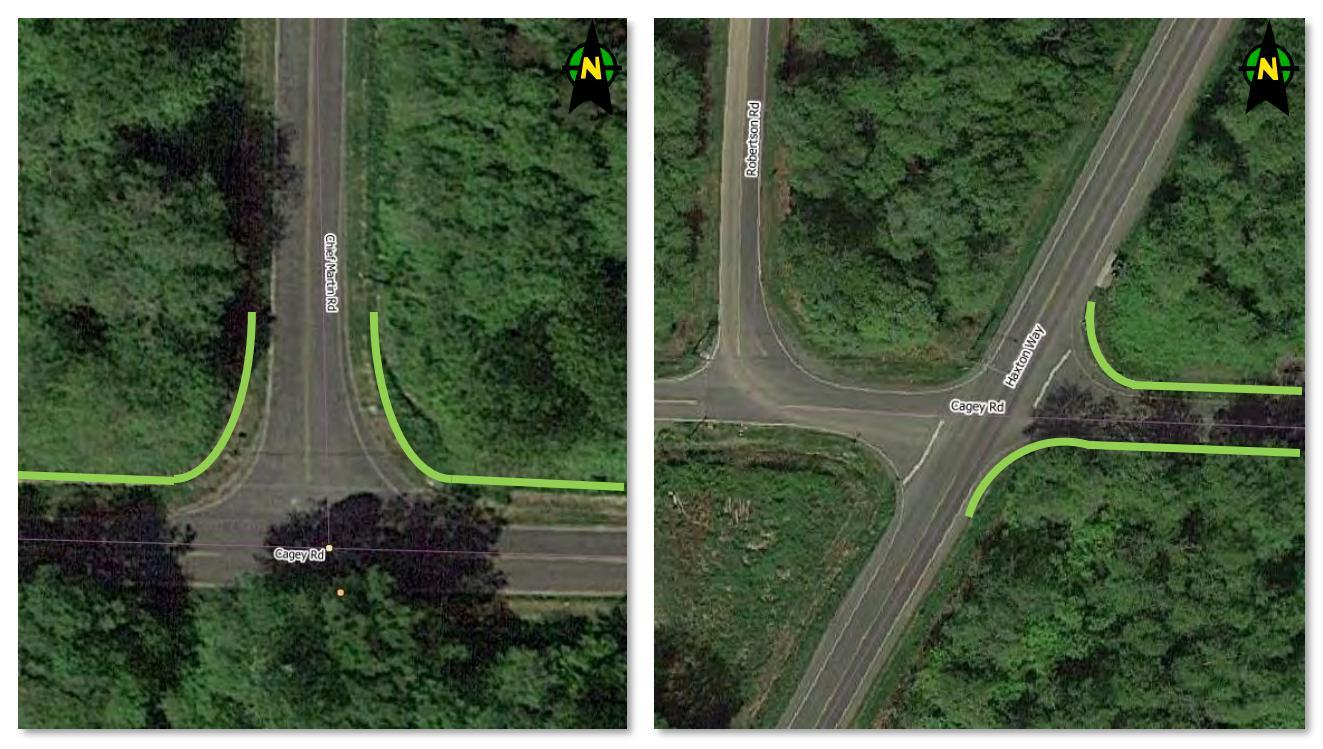
Figure 37 - Cagey Rd & Chief Martin Rd – Left, Haxton Way & Cagey Rd Intersection Sight Distance

Concerns around sight distance at intersections within the Reservation were raised in the RFP and during the kick-off meeting. Visibility was considered during the field review, and several intersections were identified where limited sight distance may be a concern. The restricted visibility at these locations requires drivers to pull forward more often in order to look for any cross traffic, exposing them to potential collisions. These incidents have the potential to result in more severe injuries as collisions of this nature tend to result in angle or left turn head on collisions. Figure 37 provides an example of an intersection identified as having limit sight distance.

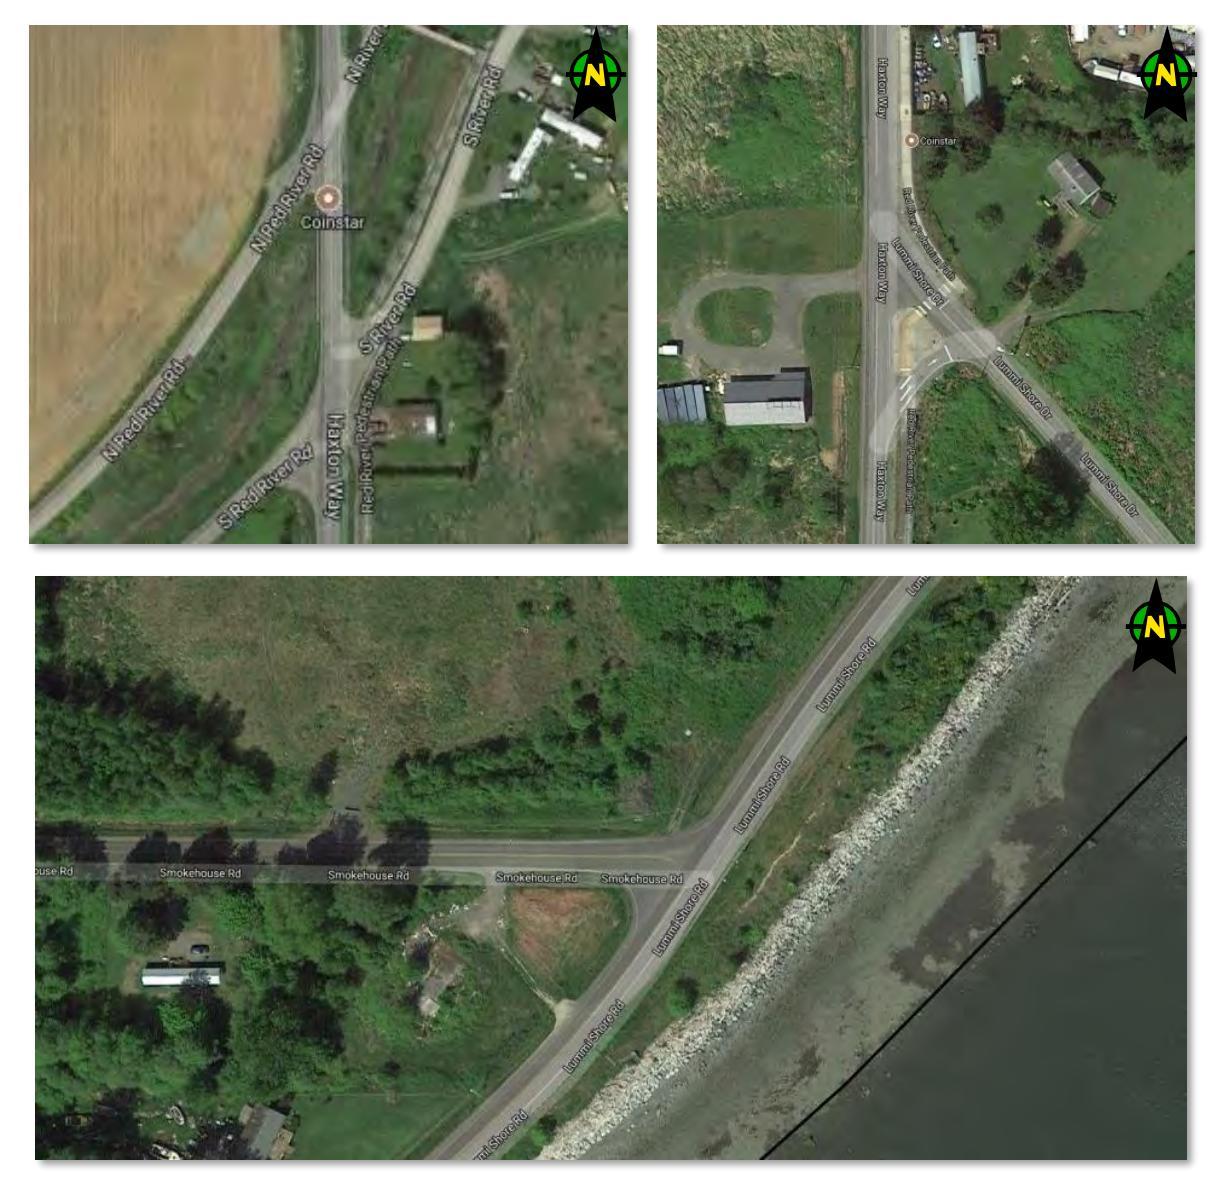
Figure 42 - Significantly Skewed Intersections (Haxton Way & Red River Rds - Top Left, Haxton Way & Lummi Shore Dr - Top Right, Smokehouse Rd & Lummi Shore Rd - Bottom)

Several intersections within the Reservation have significant skews. This restricts sight distance and makes it more difficult for physically impaired drivers to turn to look for traffic. Heavily skewed intersections also slow turning speeds and may force larger vehicles to turn into oncoming traffic lanes to complete the maneuver. The intersections of Haxton Way with both S and N Red River Rd as well as Haxton Way and Lummi Shore Dr were identified as intersections with significant skew angles. Other locations with significant skews or restricted sight distance exist at Slater Rd & S Red River Rd, **Smokehouse Rd & Lummi Shore, and locations around the "Kwina Triangle".** Figure 42 provides a series of images showing the driver's perspective at these locations.

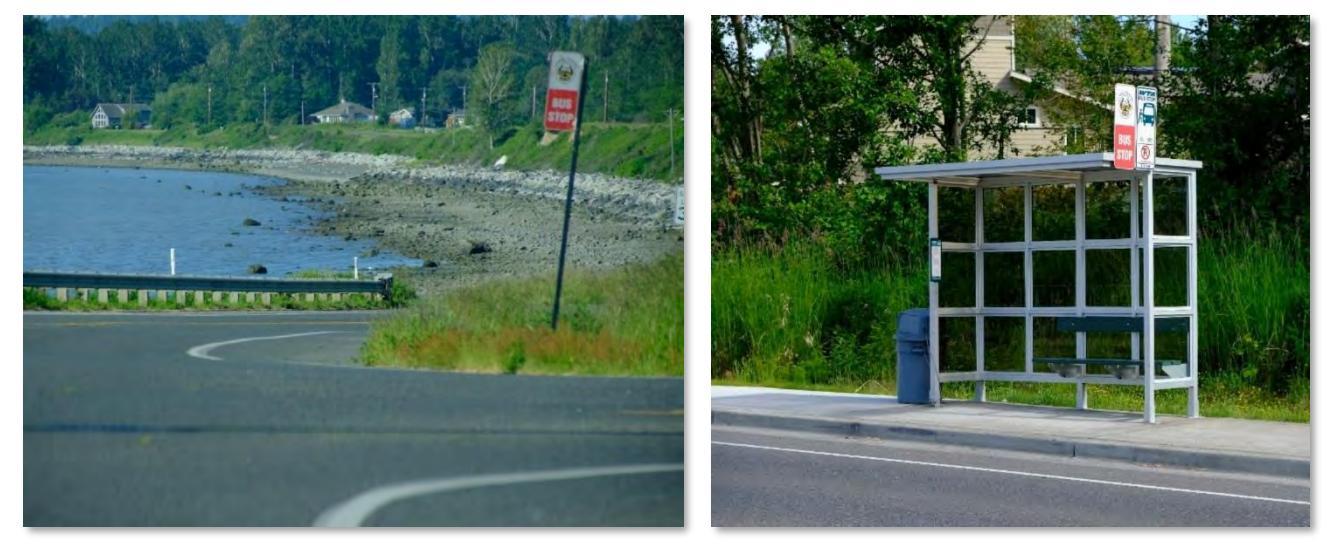
Figure 44 - Comparison of Bus Stop Facilities

The Tribe provides a regular transit service throughout the Reservation with designated bus stops along the route. While some of these stops have, or are programmed to receive, sheltered waiting areas, a significant number are currently marked by a single bus stop sign driven into the grassy clear zone. Based on discussions with local community leaders and members, this sometimes results in pedestrians waiting on the edge line of the road. In some cases, it was noted that groups of school children waiting for the bus spill onto the roadway. This is particularly hazardous at locations where there is not sufficient overhead lighting. Figure 44 provides examples of bus stops observed during the field review.

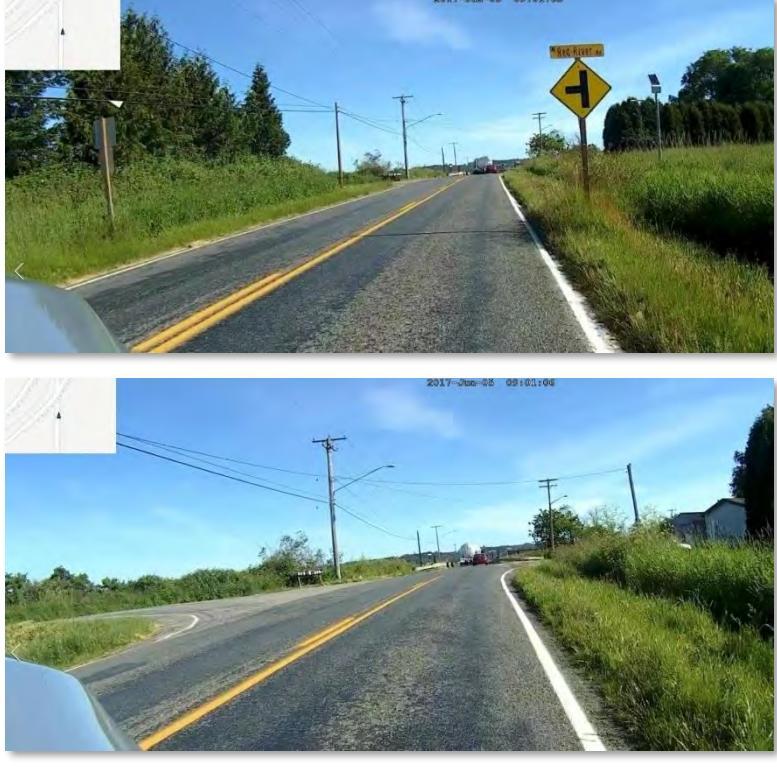
As noted during the field reviews, there are a significant portion of intersections within the Reservation that lack advanced intersection warning signs. This results in uncertainty around the upcoming location of an intersection, particularly for visitors or tourists unfamiliar with the area, as well as drivers not realizing a stop controlled intersection is ahead. Figure 46 **provides the driver's** perspective along Haxton Way approaching N & S Red River Rd. As shown in the figure, only N Red River Rd has intersections guidance signs, despite S Red River Rd coming between N Red River Rd and the guidance sign shown here.

Driver encounters S Red River Rd Intersection before Signed Intersection

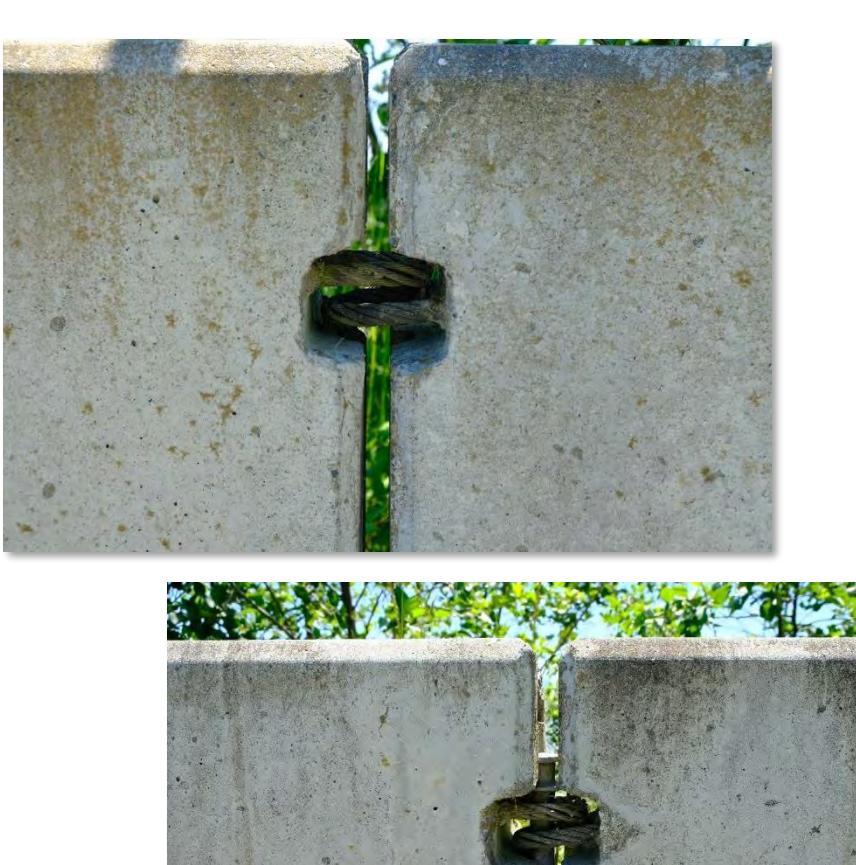
Figure 47 - Unpinned vs Pinned Jersey Barrier along Lummi Shore Rd

Jersey barrier installations have been positioned along portions of Lummi Shore Rd along the eastern side of the peninsula. These are intended to prevent drivers from leaving the roadway and falling over the beachside cliffs. It was noted during the field review that these barriers have not been pinned together, as is typical for such an installation, or pinned to the ground. This leaves open the potential that a vehicle striking the barrier may move single pieces, increasing the risk that the barrier will not **serve it's intended purpose.** Figure 47 provides an example of the observations made during the field review.

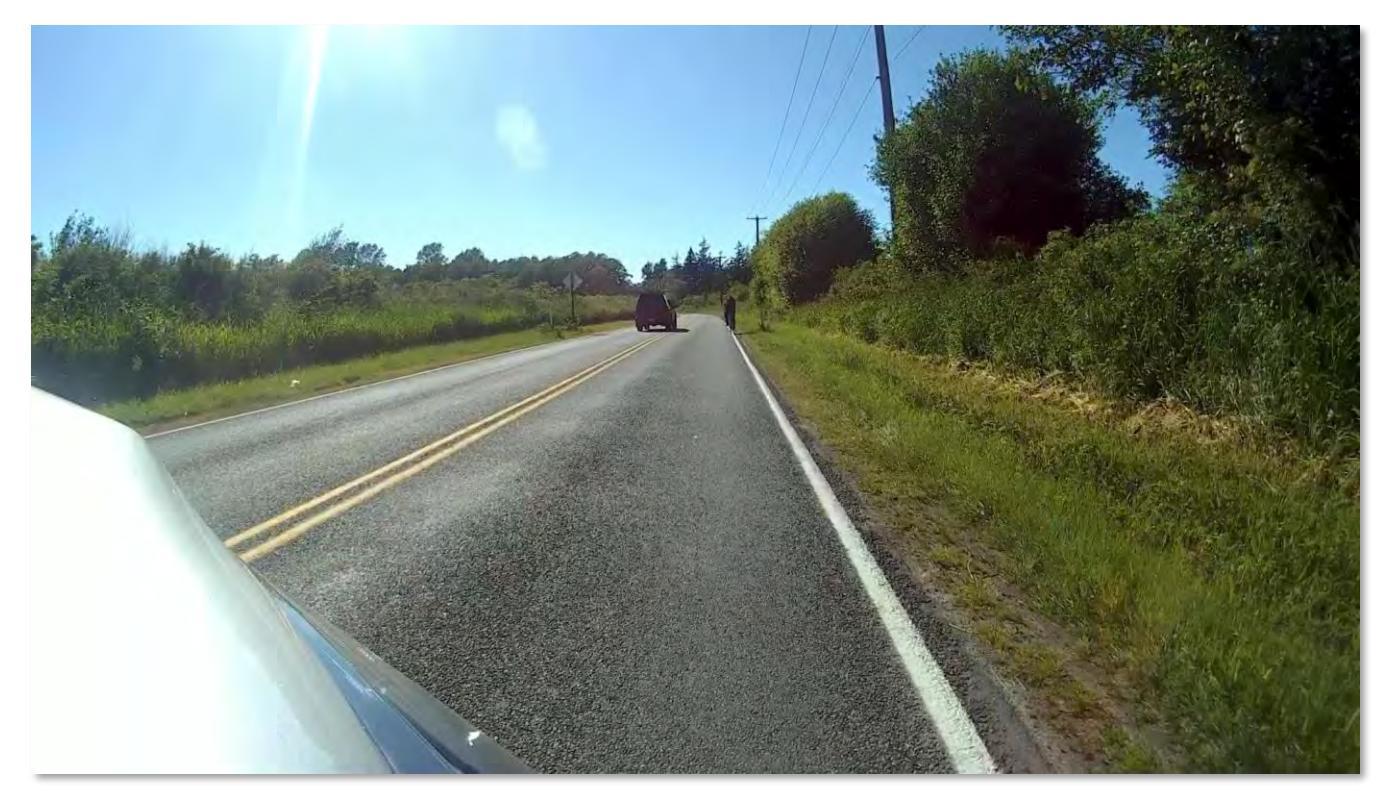
Bicyclist on Westbound Marine Dr

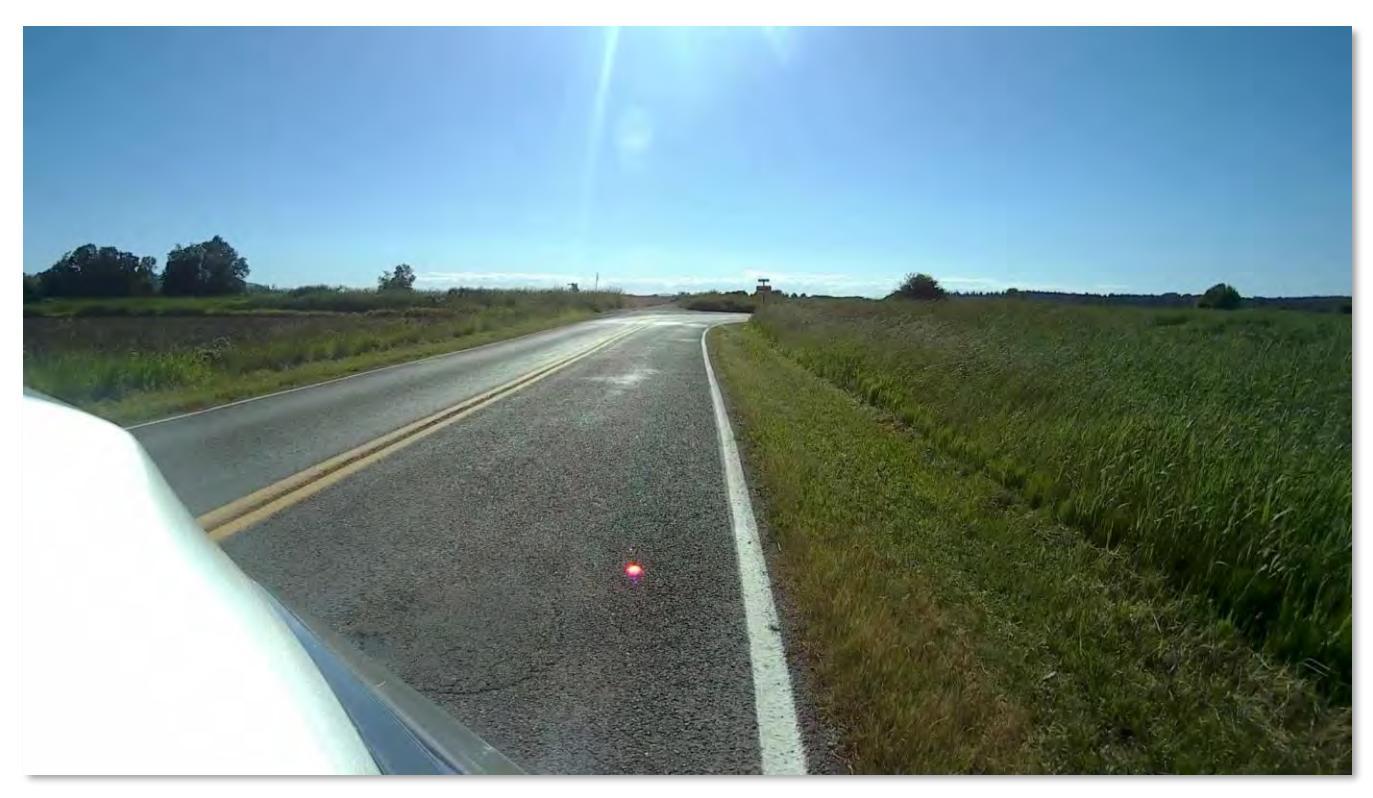
Edge Loss / Vegetation on Northbound Hillaire Rd

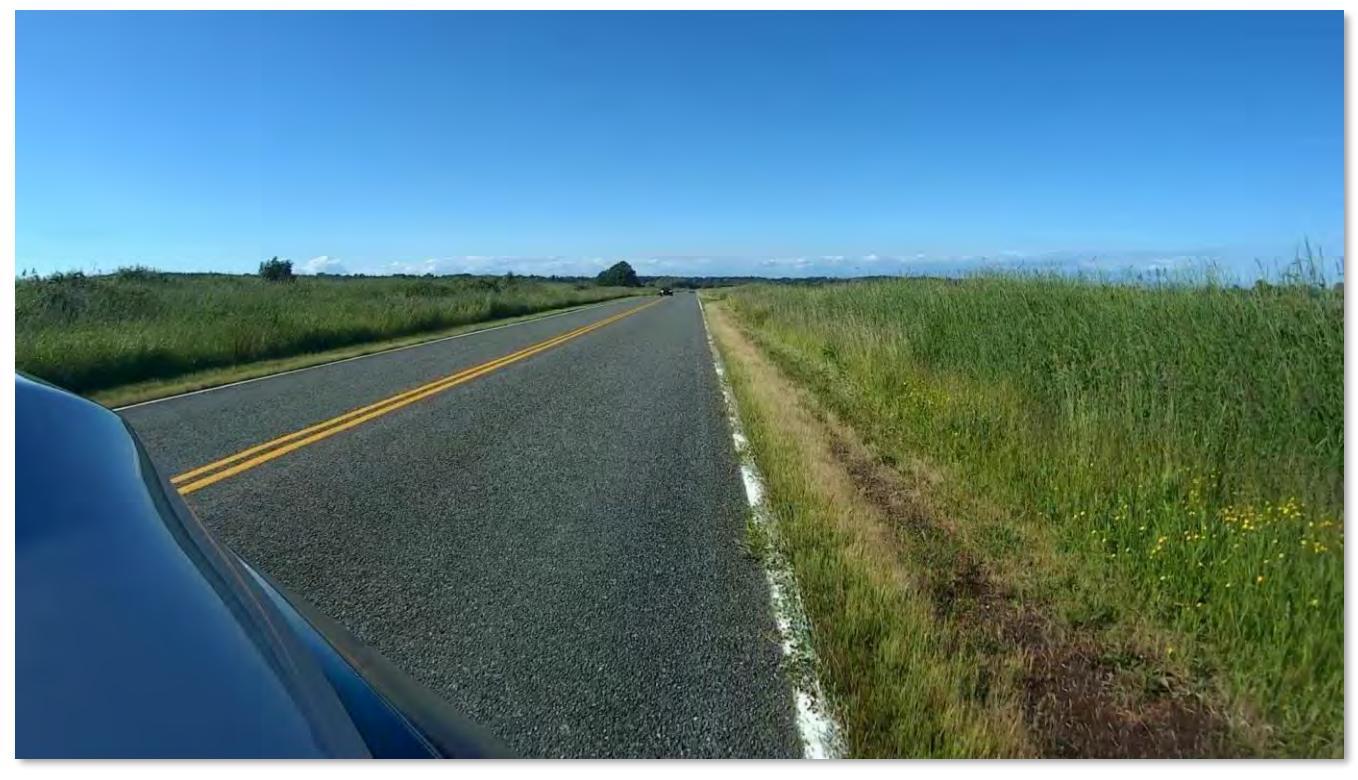
Pavement Failure on Northbound Hillaire Rd

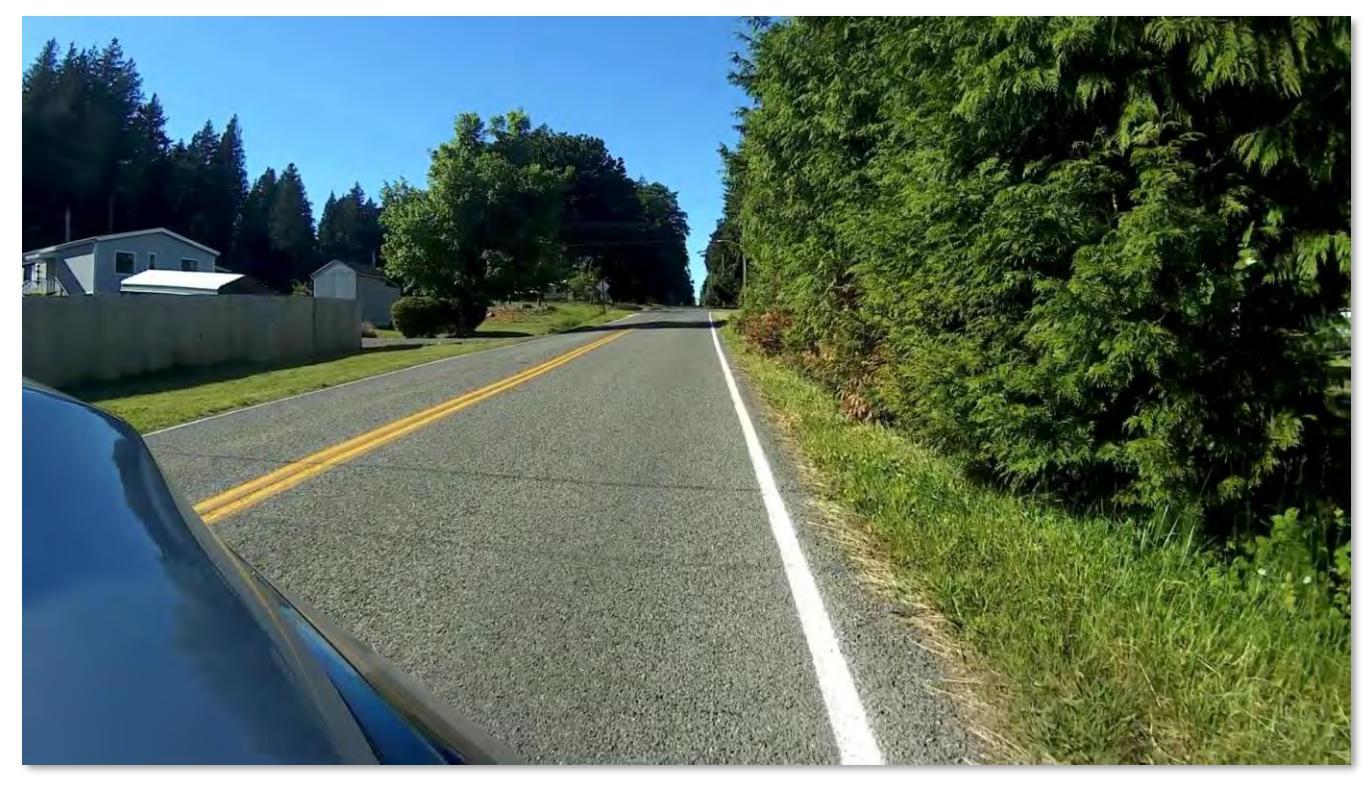
Northbound Lake Terrell Rd Narrow Clear Zone

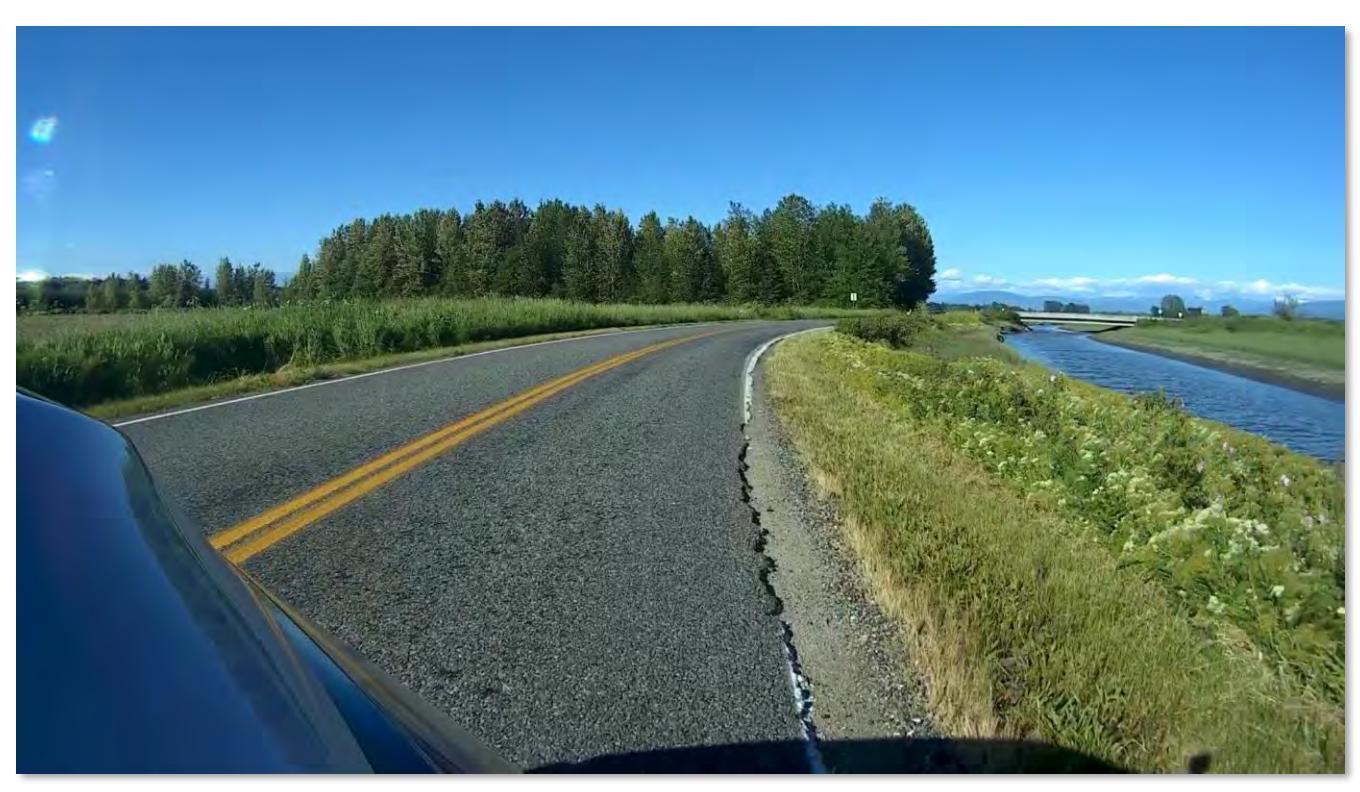
Edge Loss on Eastbound N Red River Rd West of Hillaire Rd
